# NCHRP

## SYNTHESIS 338

### Thin and Ultra-Thin Whitetopping

*A Synthesis of Highway Practice*

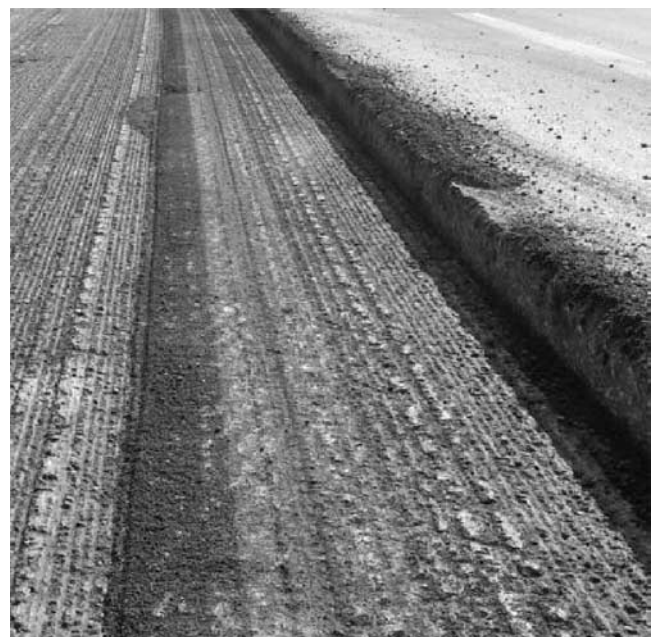
FIGURE 7 Milled HMA surface before overlay.

Depending on the equipment used, milling operations commonly remove between 25 and 75 mm (1 and 3 in.) from the surface of the existing HMA pavement. Figure 7 shows an

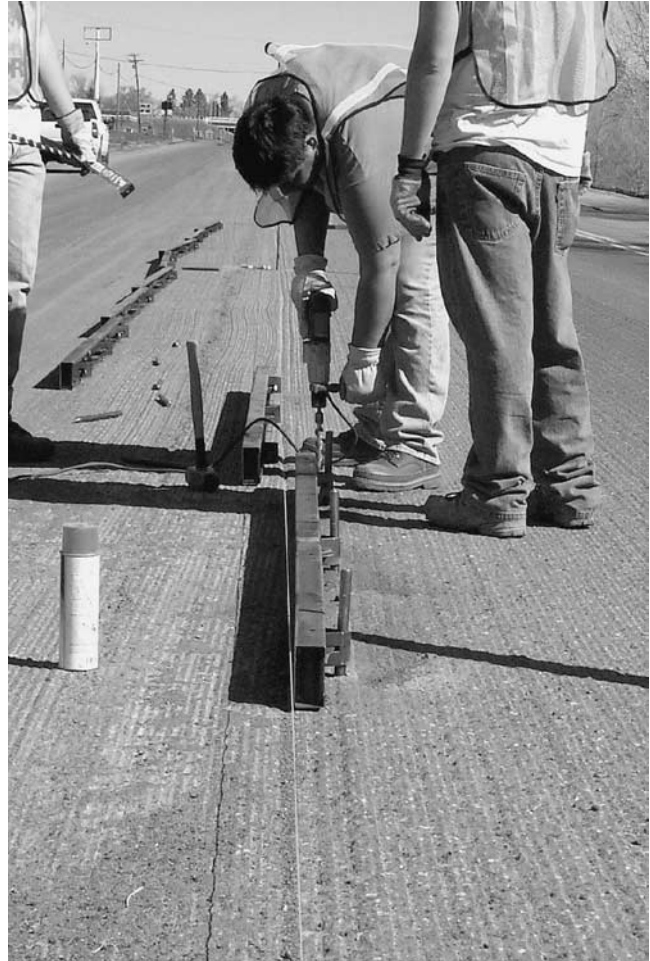
FIGURE 8 Use of fixed forms.

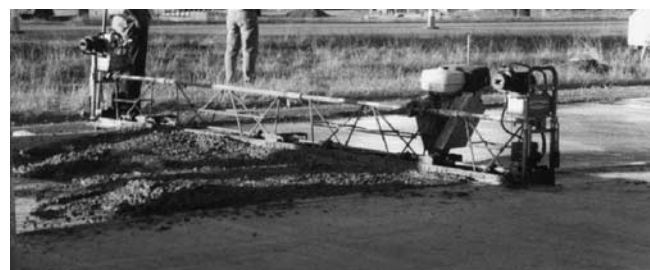
FIGURE 9 Vibrating screed.

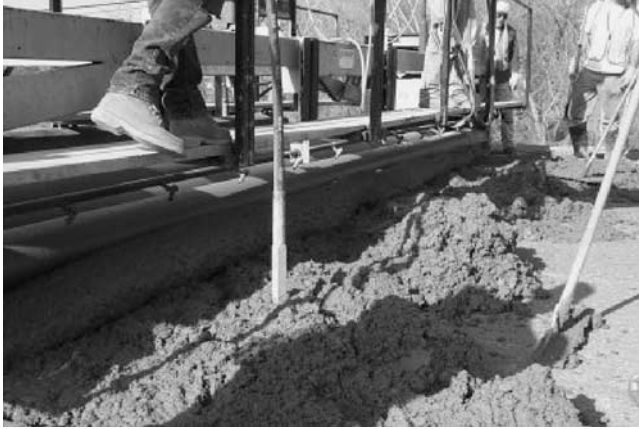
FIGURE 10 Rolling screed.

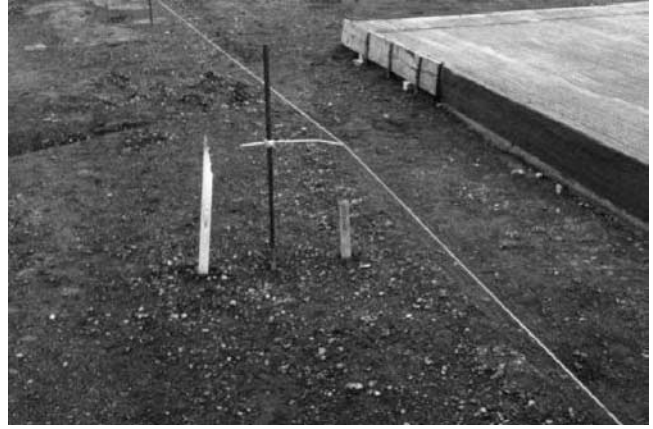
FIGURE 13 Stringline for guiding paver.

means (Figure 12). Slipform pavers usually require stringlines for horizontal and vertical grade control (Figure 13). Where possible, dual stringlines should be used to enhance grade control and smoothness. Because many slipform pavers employ automated floats, additional floating is commonly specified, although often not required behind the paver.

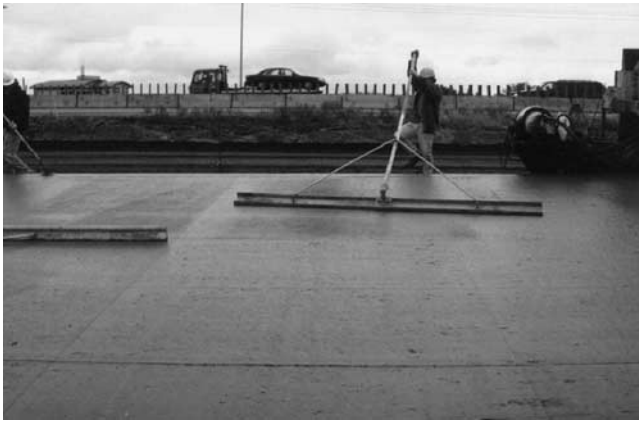
FIGURE 11 Floating.

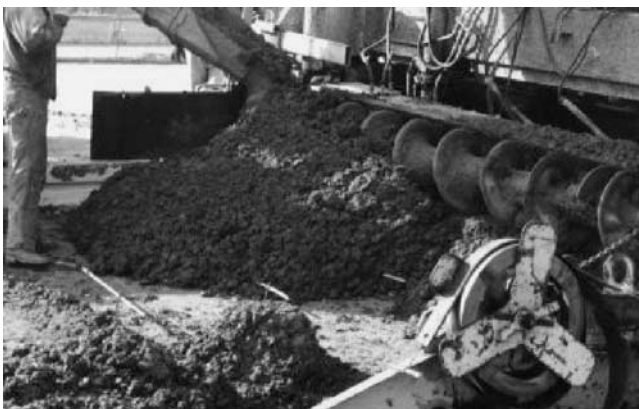
FIGURE 12 Use of a slipform paver.

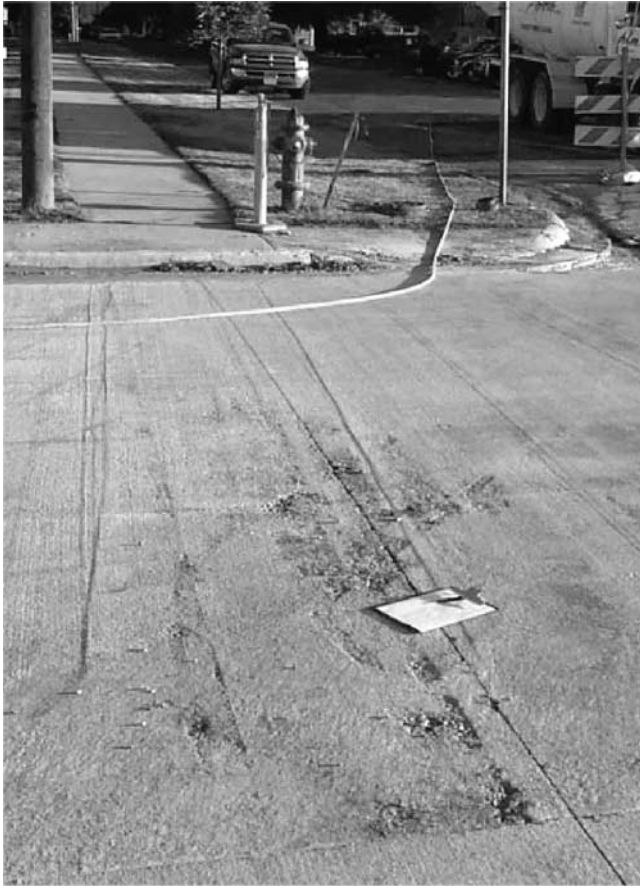
FIGURE 14 Poor consolidation.

A potential problem with the use of baskets is voids beneath the dowels and the basket steel. The contractor must ensure that the concrete is consolidated adequately to eliminate voids that may form beneath the dowels held in a basket, but that it not be overvibrated, which would cause segregation or excessive loss of air.

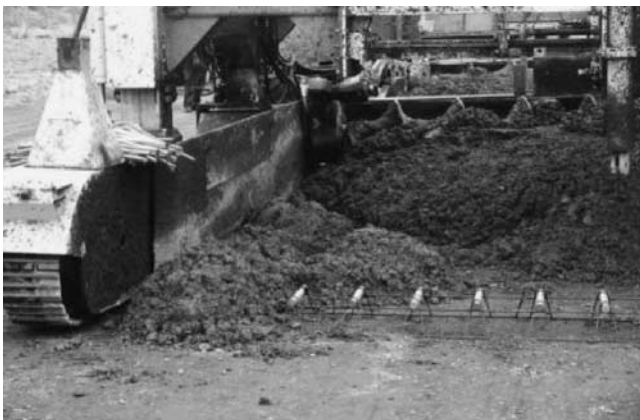
FIGURE 15 Concrete being placed over a dowel basket.

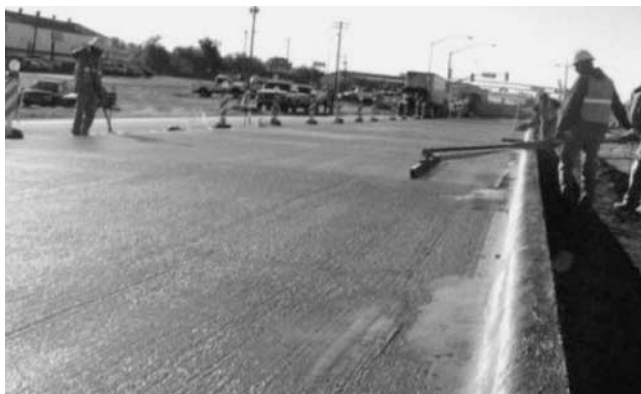
FIGURE 18 Water sheen on a concrete surface.

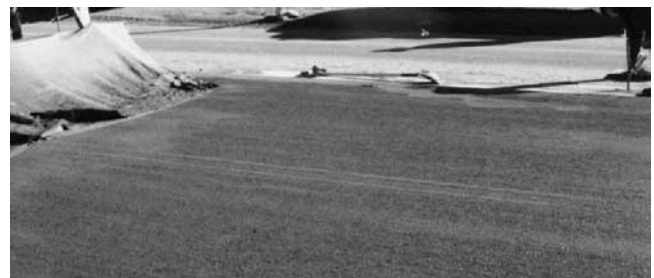
FIGURE 19 Application of texture with a burlap drag.

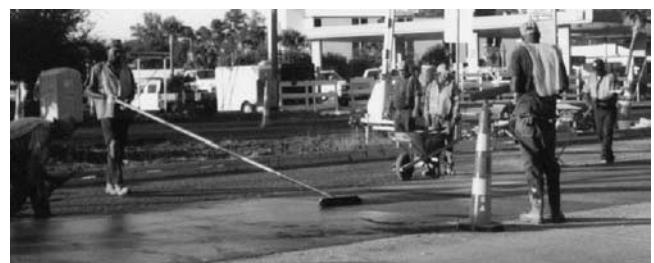
FIGURE 20 Application of texture with a coarse broom.

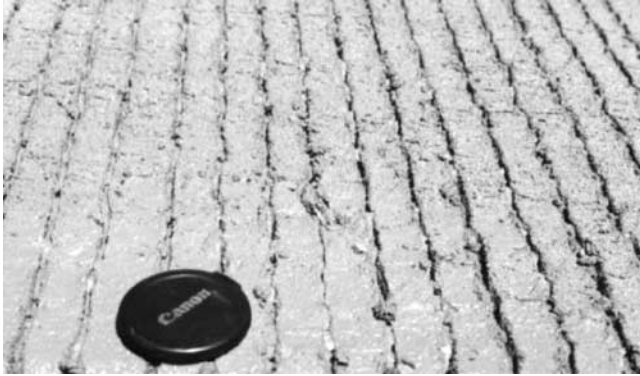
FIGURE 21 Tining comb texturization on freshly placed concrete.

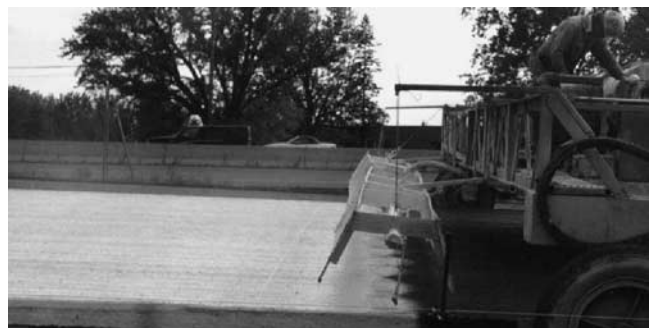
FIGURE 22 White-pigmented, liquid membrane curing compound.

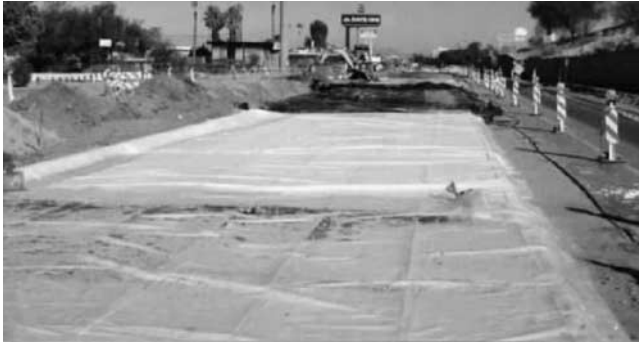
FIGURE 23 Polyethylene sheeting used as a curing method.

**Plastic or Waterproof Paper** Plastic (typically polyethylene) sheeting provides good protection to the concrete from water evaporation from the surface (see Figure 23) (39). It requires more labor than liquid curing compound, yet it is not as bulky as cotton mats or burlap. Waterproof paper may also be used in the same manner described here for plastic sheeting, but it is not as common.

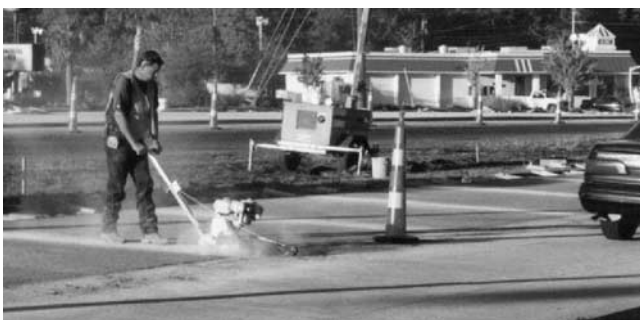
FIGURE 24 Sawcutting on a fast-tracked UWT.

Early entry or “green” sawcutting is a technique that can help to ensure that the joints are cut in a timelier manner (see Figure 24). According to the user survey, this method is more commonly used than is conventional sawing. Early entry saws are readily available and have been developed specifically

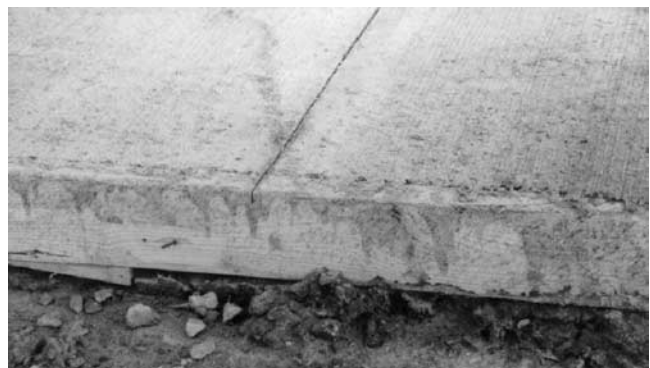
FIGURE 25 Sawcut depth using an early-age saw.

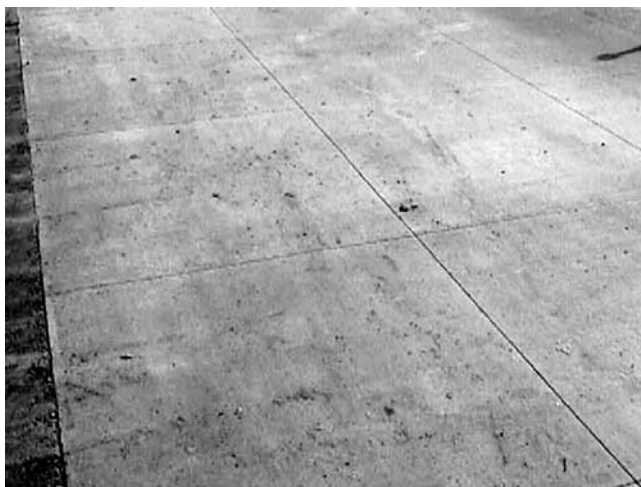
FIGURE 26 Joints without joint sealant.

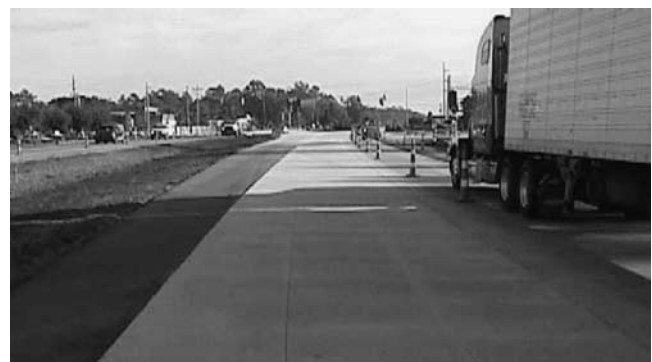
FIGURE 27 New shoulders meeting a new whitetopping elevation.

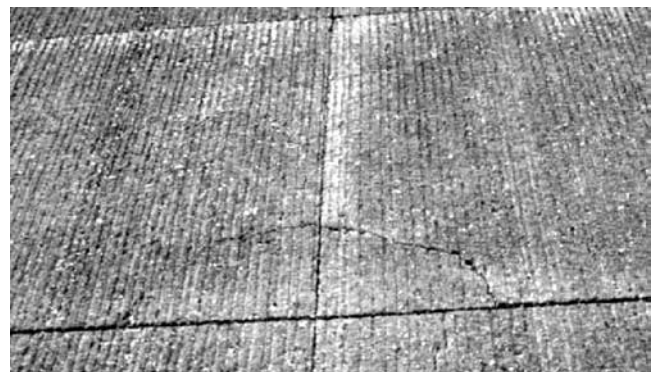
FIGURE 30 Typical corner crack on a UTW.

A corner crack may or may not affect the performance of the overlay, depending on the severity and cause of the crack. If the corner crack results from deformation of the underlying layer, or from debonding, then it may be necessary to repair the crack with a full-depth repair (145). If the cracked corner is not faulted or debonded, it could be left alone until it becomes a ride problem or hazardous debris problem. Some agencies may wish to repair any corner crack, given its potential to debond and become a hazard to the driving public.

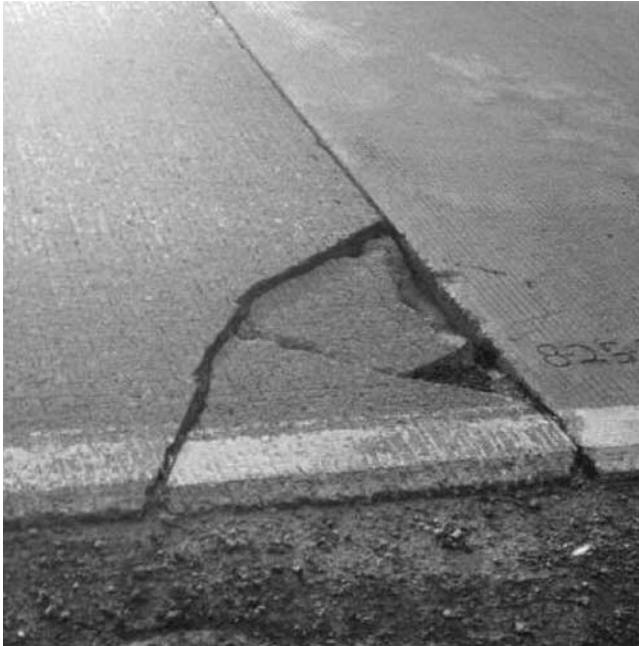
FIGURE 31 Deteriorated corner crack on a TWT.

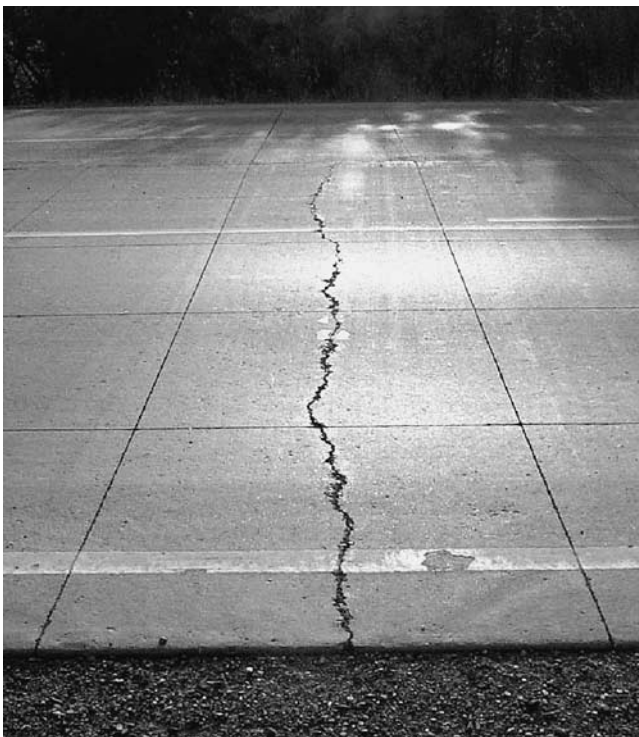
FIGURE 32 Typical midpanel crack on a TWT.

Midpanel cracking can occur together with other distresses, similar to the situation for corner cracking. Midpanel cracking usually does not warrant repairs, especially in UTW (146). However, on some TWT overlays, crack sealing may be an appropriate method of repair. Figures 32 and 33 show typi-

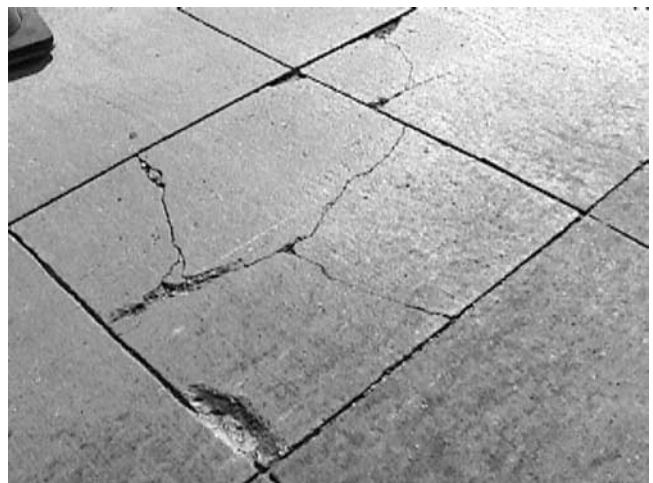
FIGURE 34 Typical shattered slab on a UTW.

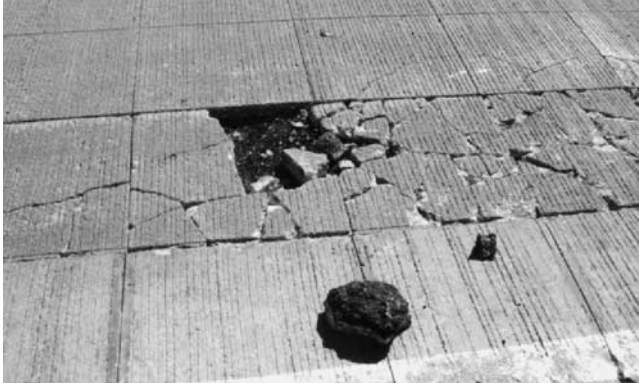
FIGURE 35 Severely shattered slabs on a UTW.

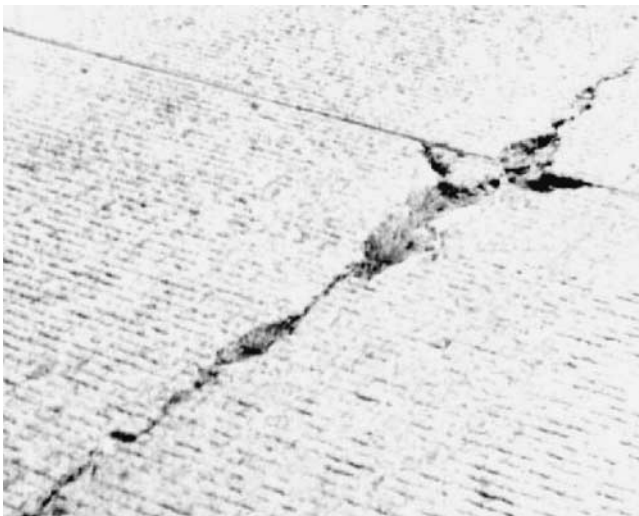
FIGURE 36 Severely spalled crack.

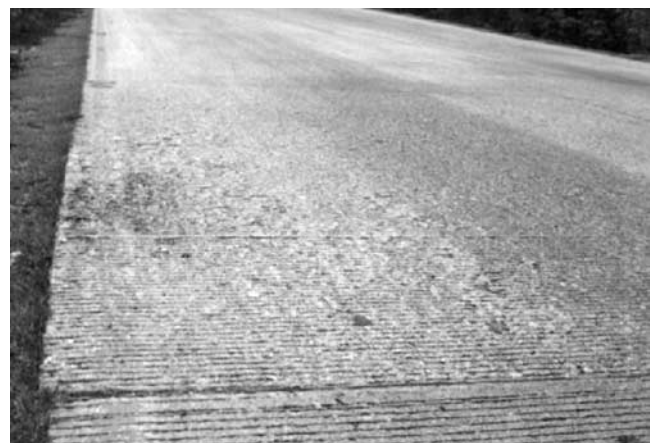
FIGURE 37 Typical surface wear.

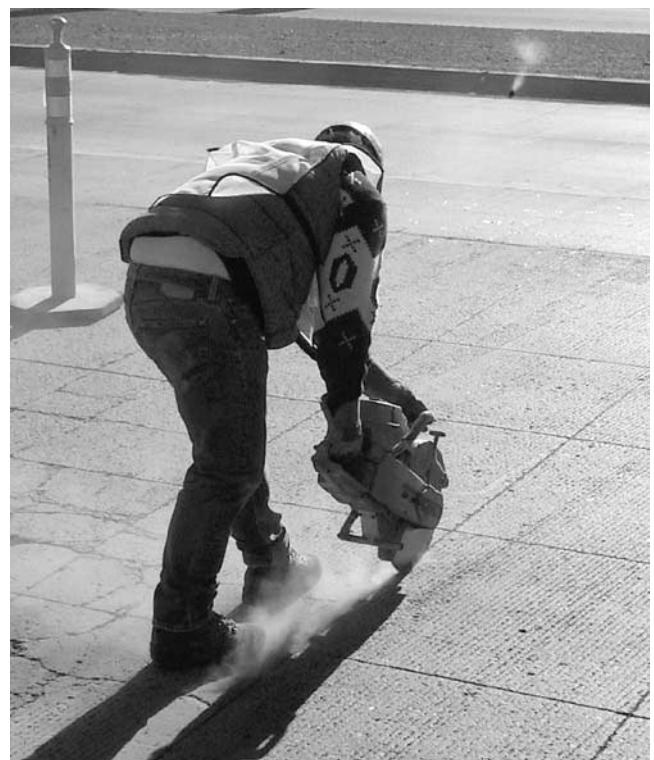
FIGURE 38 UTW repair step 1—Outline sawing.

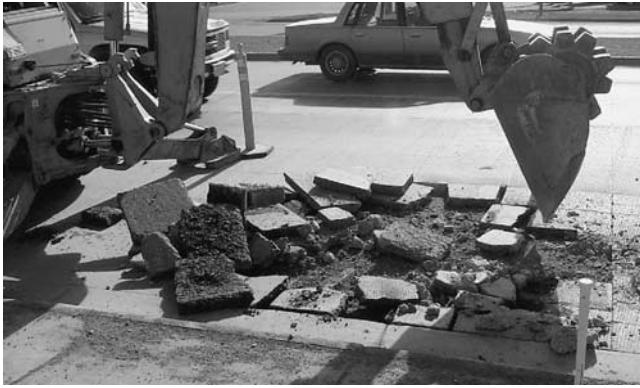
FIGURE 39 UTW repair step 2—Removing panels.

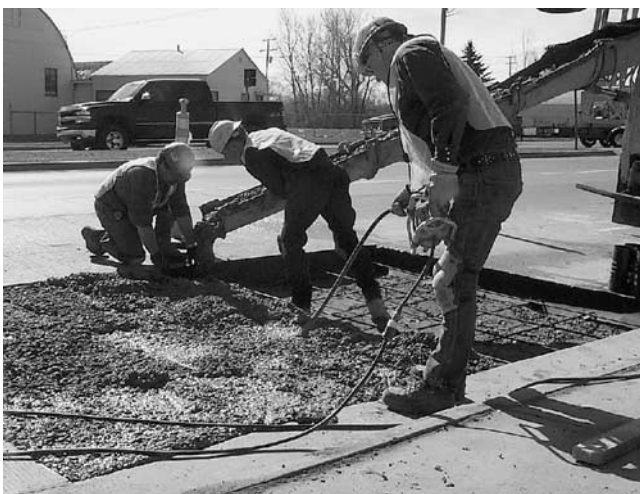
FIGURE 40 UTW repair step 3—Place new PCC.

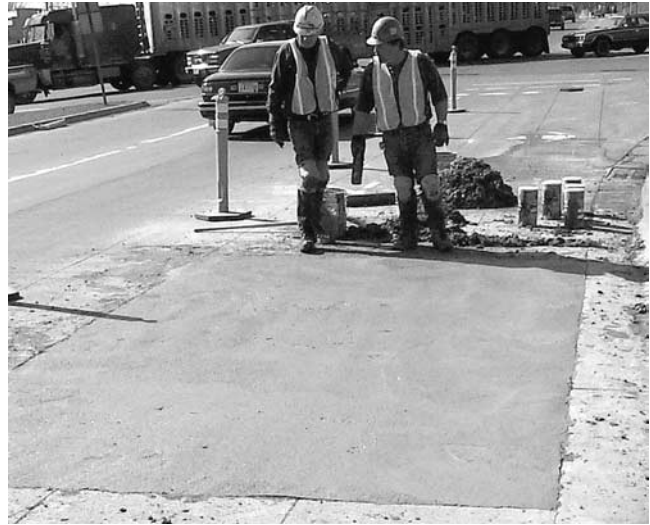
FIGURE 41 UTW repair step 4—Finish and cure PCC.

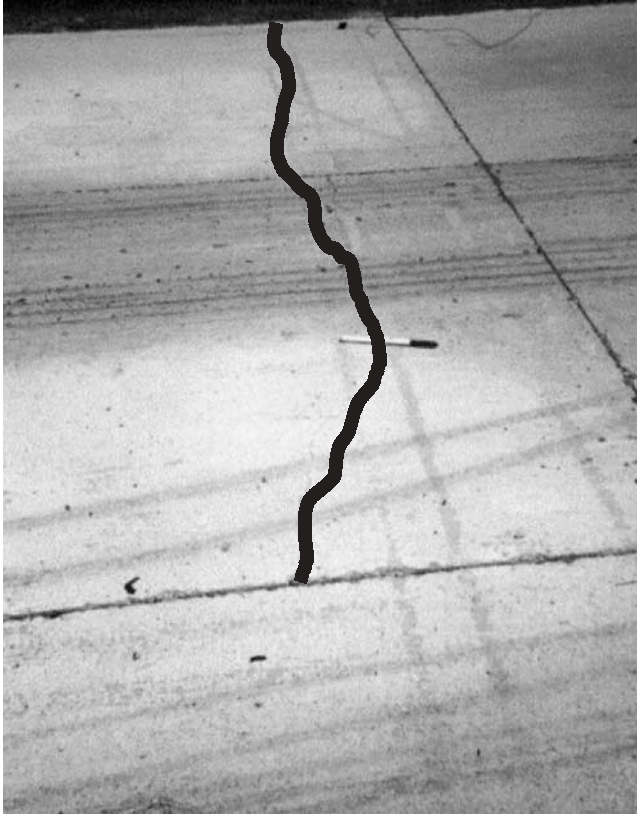
FIGURE B12 Typical UTW transverse cracking at the FHWA ALF.

The panels in this lane were heavily damaged. With the exception of the southernmost panel, every panel along the loaded column of slabs had some form of cracking. The majority of these panels demonstrated corner cracking. Three of the panels also had transverse cracking. A significant degree of joint faulting along the longitudinal joint adjacent to the load was also observed. In the panels adjacent to the loaded column of panels, some additional cracking was observed. It appeared that most of this cracking was reflected across the longitudinal joint from the center-loaded column of panels.

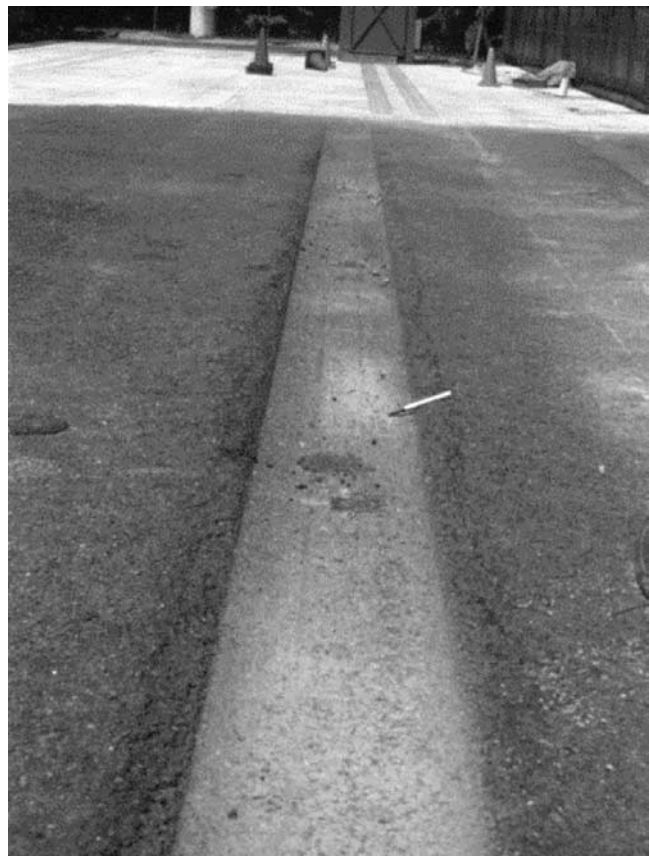
FIGURE B16 Typical HMA rutting at the FHWA ALF.
