REPORT 477

Recommended Practice for Evaluation of Metal-Tensioned Systems in Geotechnical Applications

TRANSPORTATION RESEARCH BOARD

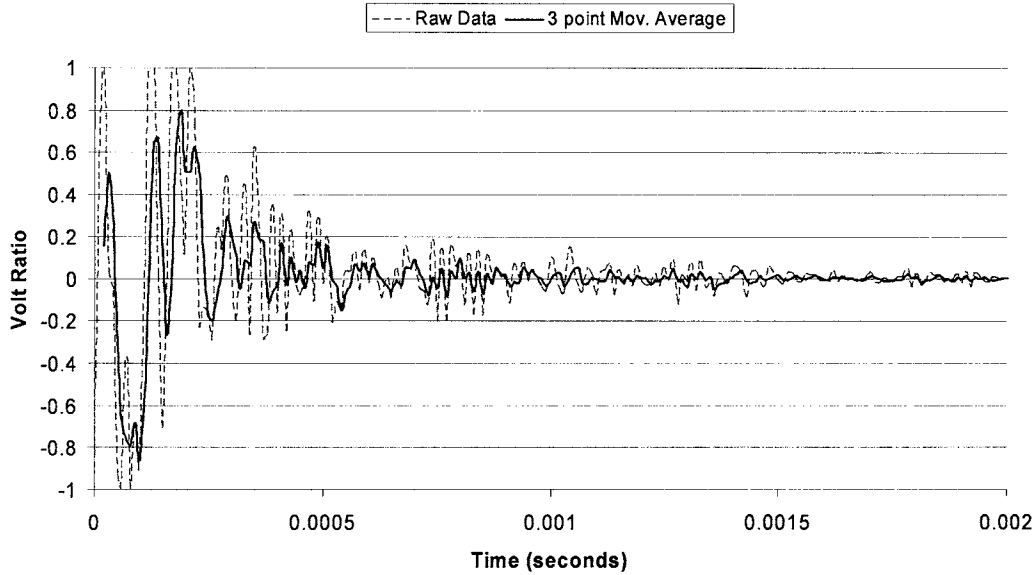
Figure 3-6. Ultrasonic test data and corresponding moving average plots.

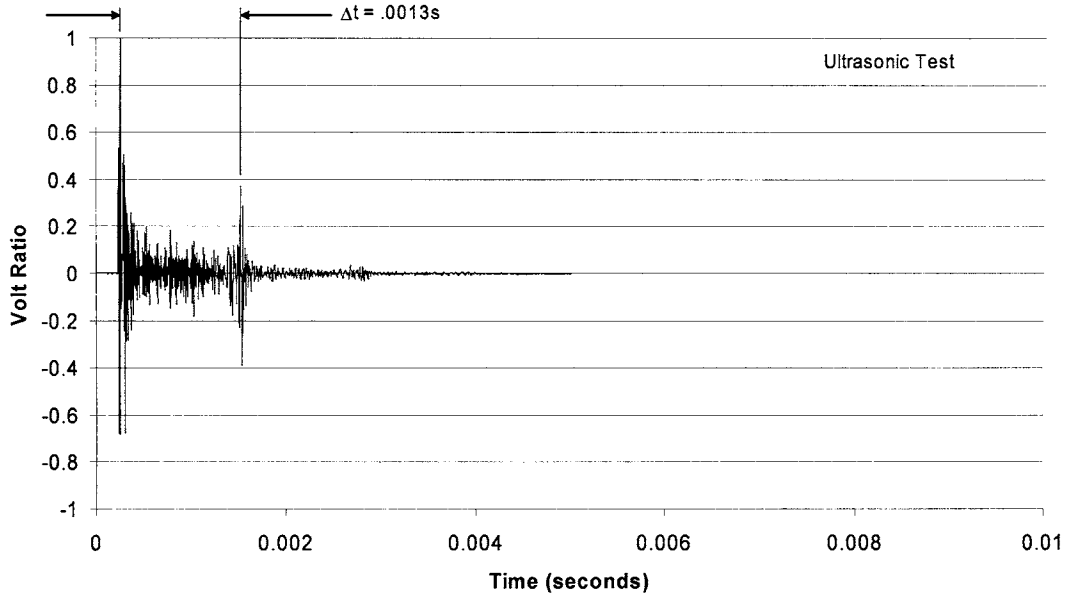
Figure 5-6. Ultrasonic test results for epoxy-coated bar without defect at UB test facility.

Figures 5-6 and 5-7 show results from ultrasonic tests conducted on the same epoxy-coated elements (Elements 3 and 4) for which impact test data were presented. Similar to the results obtained with the impact test, a distinct reflection is observed approximately 0.0011 s after the ultrasonic excitation pulse. Compared with the results from the intact bar, the relatively small amplitude of the reflection from the end of the defected bar is readily apparent. The smaller amplitude is due to reflections and refractions from the defect and associated loss of energy. An additional reflection is perceptible for the bar with the defect. Thus, the presence of the defect is manifested in the test results. The data from the ultrasonic test confirm the results obtained from the impact test. The data are very useful because similar results are obtained when the

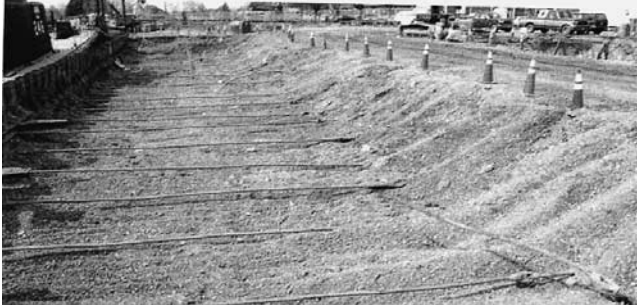
Figure 5-8. Thirty-three-year-old bars in free-draining gravel behind old quay wall unearthed at Buffalo Inner Harbor project.

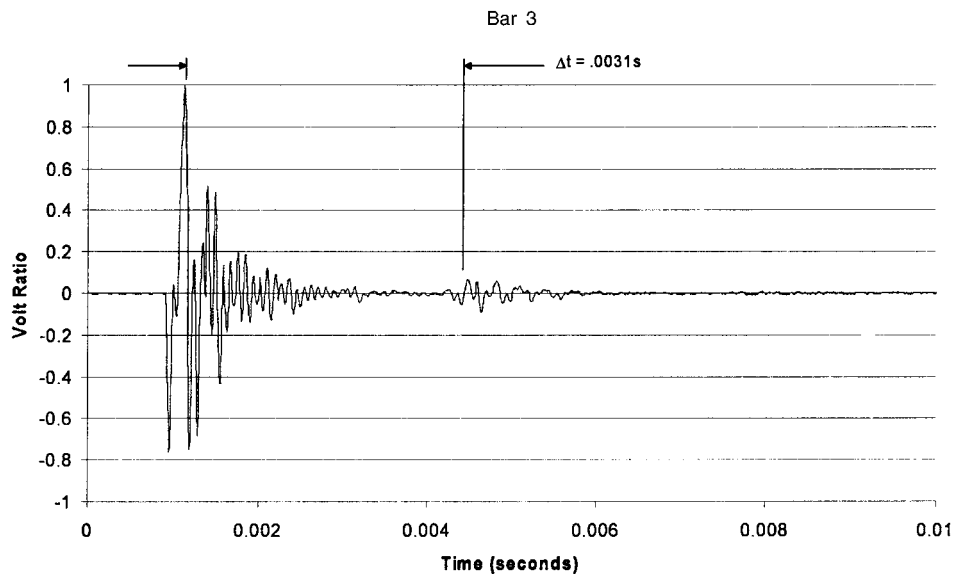
Figure 5-9. Comparison of time histories from impact tests performed on Bars 1-3 at Buffalo Inner Harbor.

NDT was performed on three adjacent elements at the site that were located at a spacing of approximately 2 m. Bar 1 was located in the middle, and Bars 2 and 3 were located approxi-

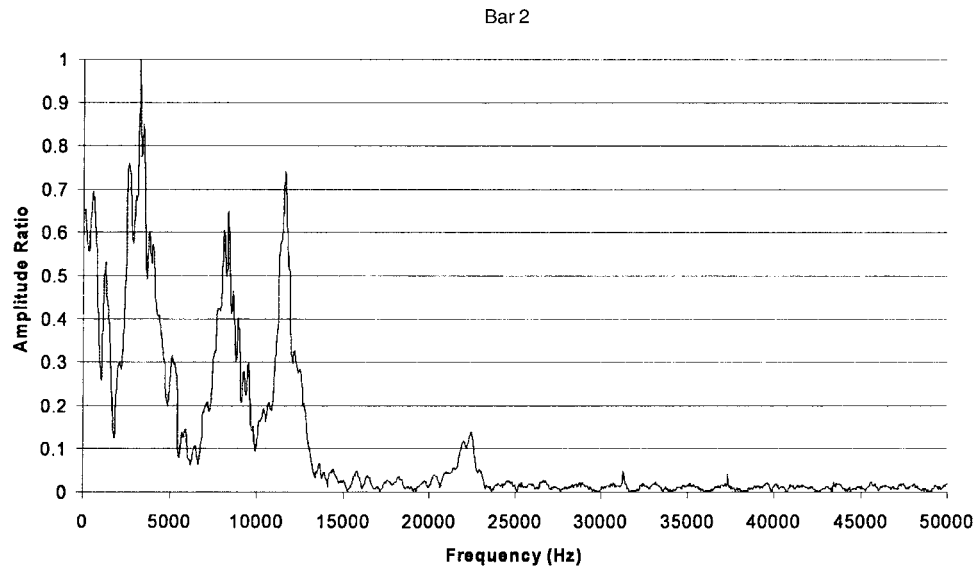
Figure 5-10. Amplitude spectra from impact tests on Bars 1–3 at Buffalo Inner Harbor.

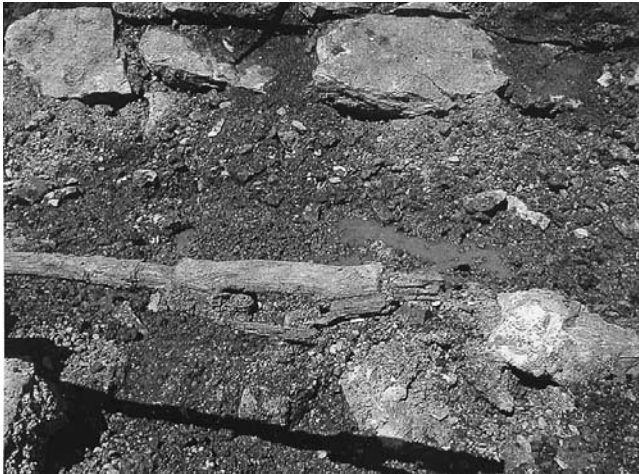
Figure 5-13. Corroded 70-year-old element backfilled in slag, exhumed at east end of Buffalo Inner Harbor project.

Backfill within the area of the dig was much different from what was observed behind the quay wall. Within the dig area, slag and cinder ash were used as backfill. These materials, which are waste products from steel manufacturing, are characterized by neutral to slight alkalinity and high salt concentrations. Samples of the slag backfill were taken and tested for pH, resistivity, sulfates and chlorides. Test results are presented

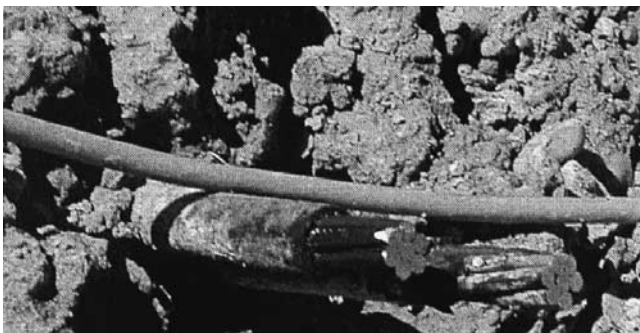
Figure 5-15. Strand ends tested at Sennet, New York.

The ends of the tiebacks were ground flat and smooth with a surface grinder in preparation for UT, as shown in Figure 5-15. Four strands were tested, which were from two pairs of adjacent tiebacks. The test results, shown in Figure 5-16, were processed with a scaling function to enhance the observed reflection. The reflections from the four strands were observed at approximately 0.0012 s, which corresponds to a distance of 3.3 m from the cut end of the element. The observed reflections are likely due to the interface between the bonded and unbonded zones. At this point, the plastic sheath is discontinued and the steel strands are surrounded by grout. The different impedance between the bonded and unbonded zones

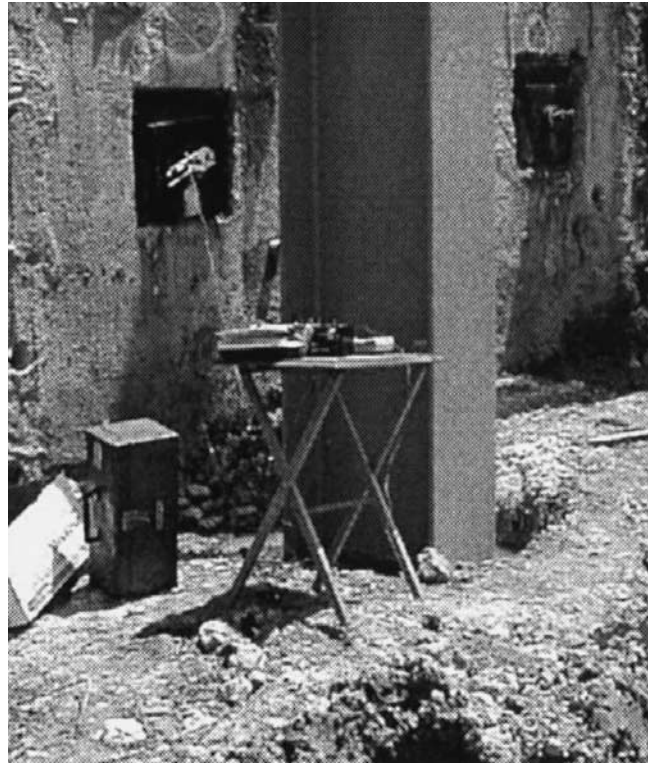
Figure 5-19. Electrical measurements being made at O Street wall, Washington, D.C.

Electrochemical tests were performed by clamping one end of an eight-gauge wire to the exposed end of the anchor rod, as shown in Figure 5-19. The half cell was pushed into the ground in front of the wall panel. Different placements of the half cell were also evaluated, including using a wet sponge to make contact with the wall face. Measurements of half-cell potential were not sensitive to placement of the half cell.

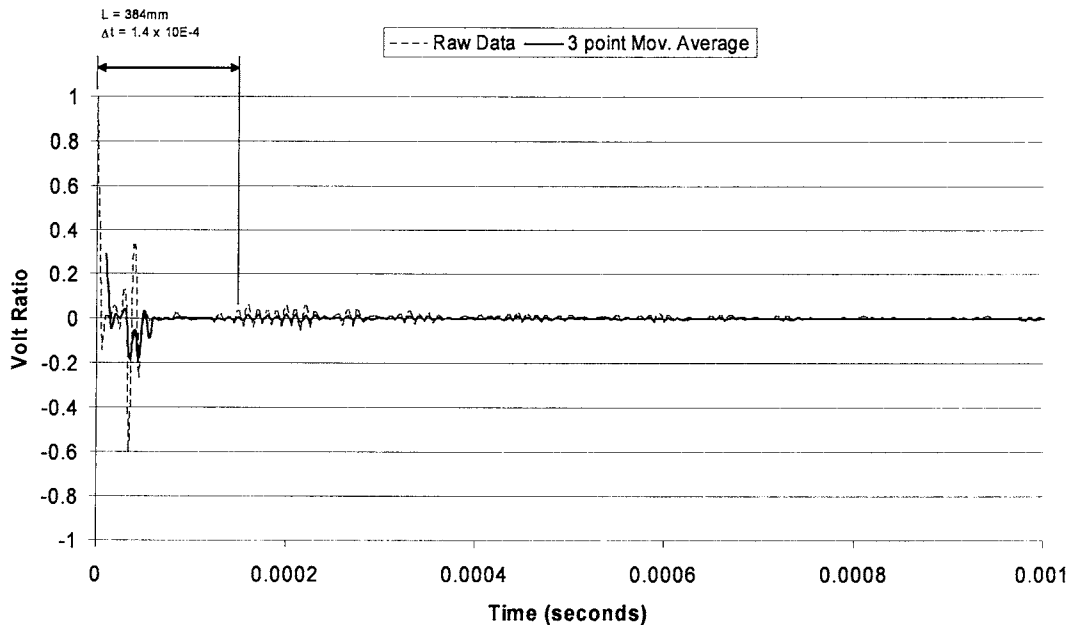
Figure 5-22. Typical ultrasonic test results from bar element at O Street, Washington, D.C.

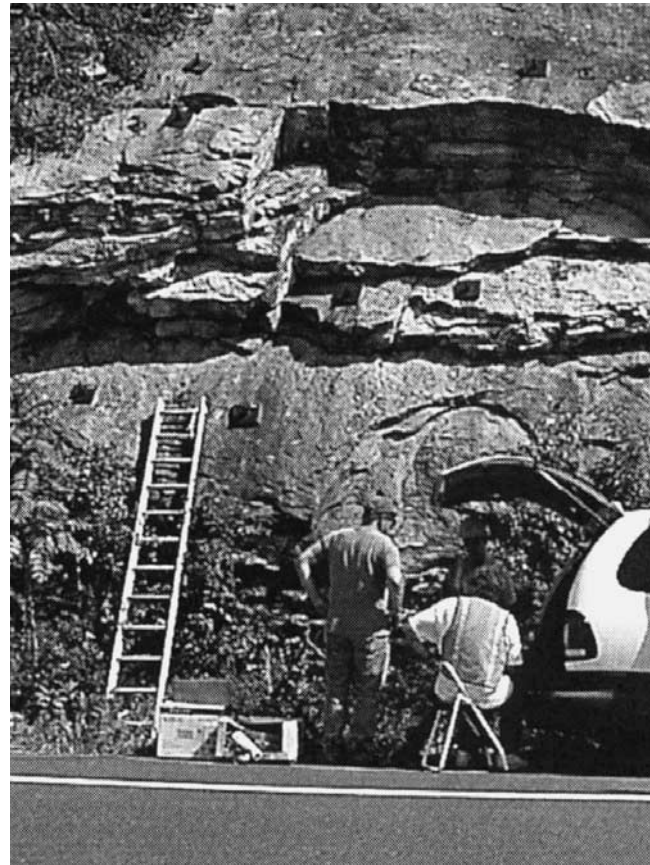
Figure 5-23. Rock slope with benches and different levels of rock bolts at Ellenville, New York.

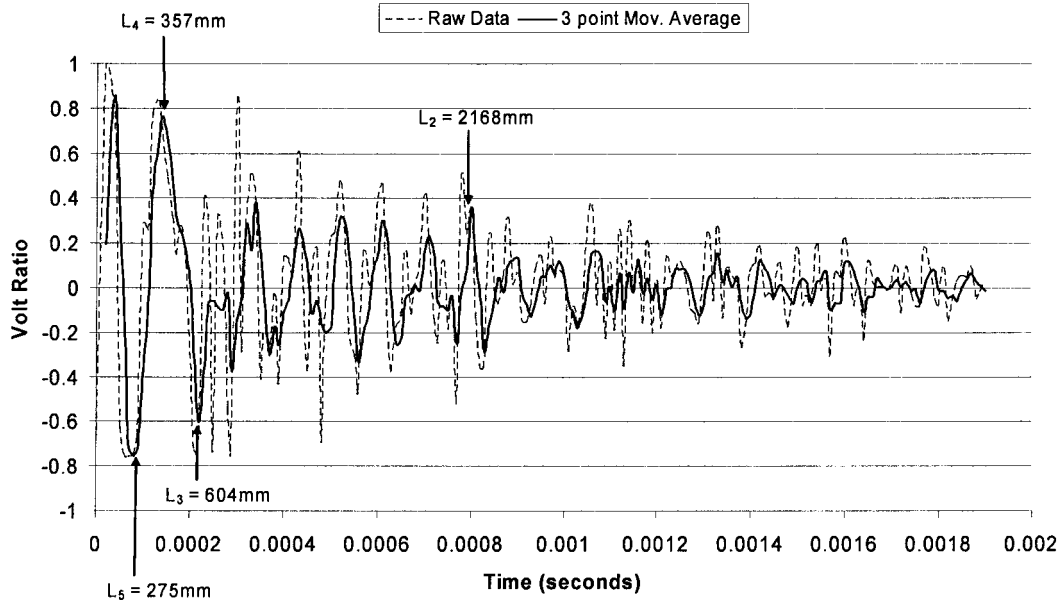
Figure 5-34. Typical ultrasonic test result for rock bolt at Dresden Station, New York.

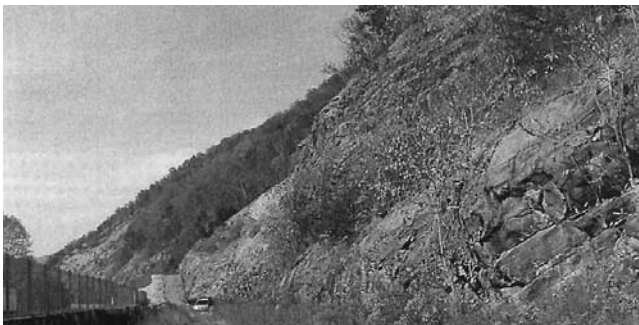
Figure 5-35. Rock slope at Pigeon Gorge, I-40 in North Carolina.

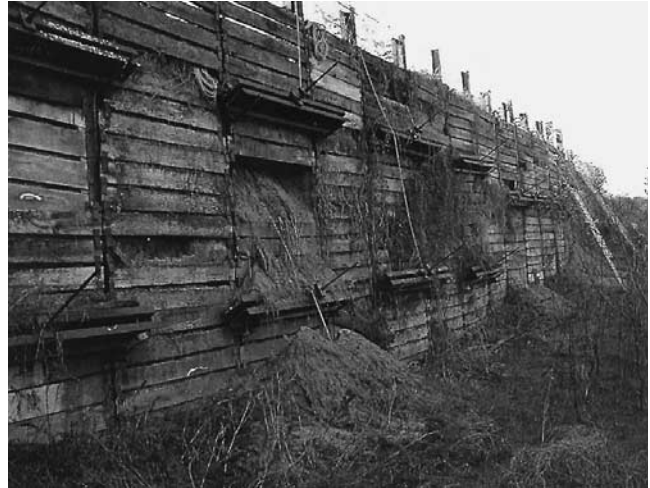
Figure 5-40. Tieback wall at TAMU-NGES.

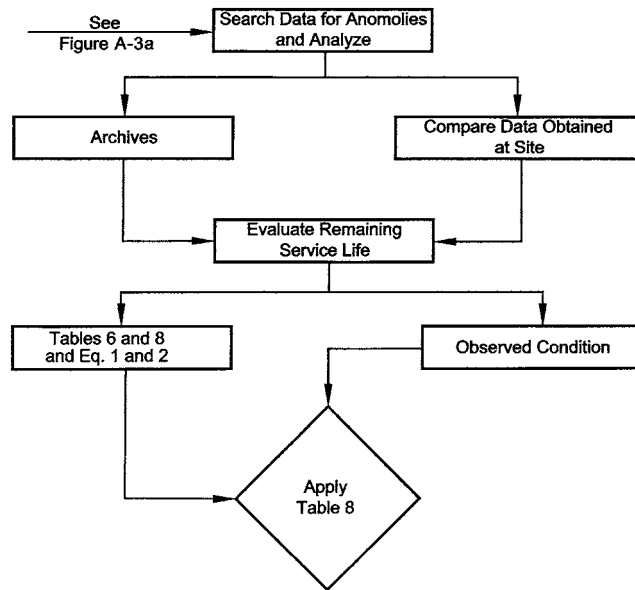
Figure A-3b. Process for condition assessment and service life evaluation of buried metal-tensioned elements.

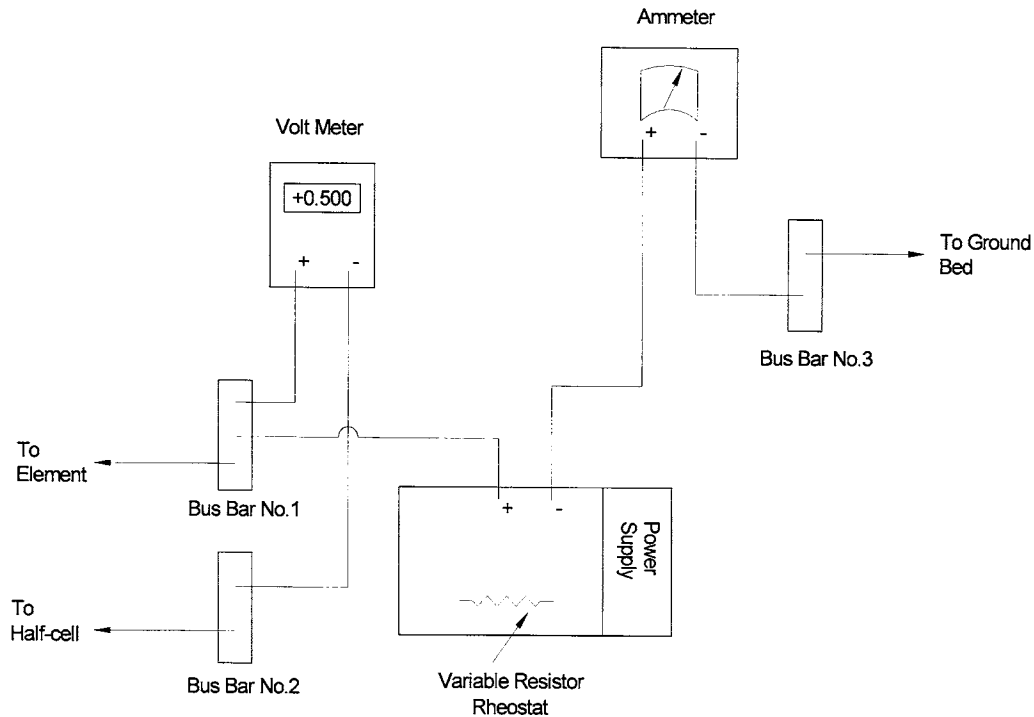
Figure D-2. Schematic of components and connections for measurement of polarization current.
