# **LTPP Data Analysis: Effectiveness of Maintenance and Rehabilitation Options**

**Prepared for:**  
**National Cooperative Highway Research Program**  
**Transportation Research Board**  
**National Research Council**

**June 2002**

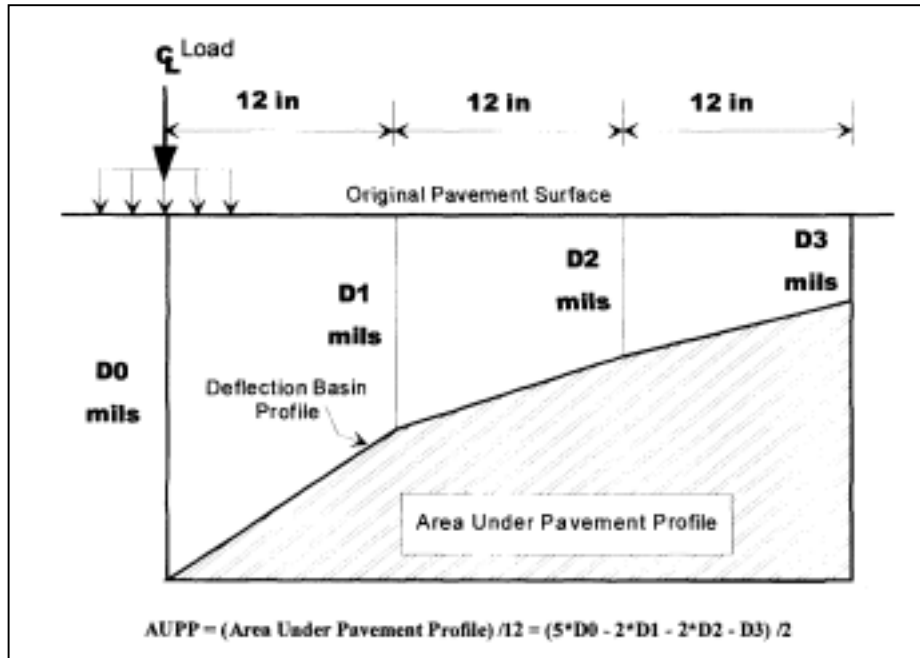
Figure 5. Illustration and calculation of Area Under Pavement Profile (AUPP).<sup>4</sup>

The definition and calculation of AUPP are illustrated in Figure 5. This or any of several other basin curvature parameters may be used to estimate the strain in the asphalt concrete layer, which in turn may be used to estimate the remaining fatigue life of the pavement.

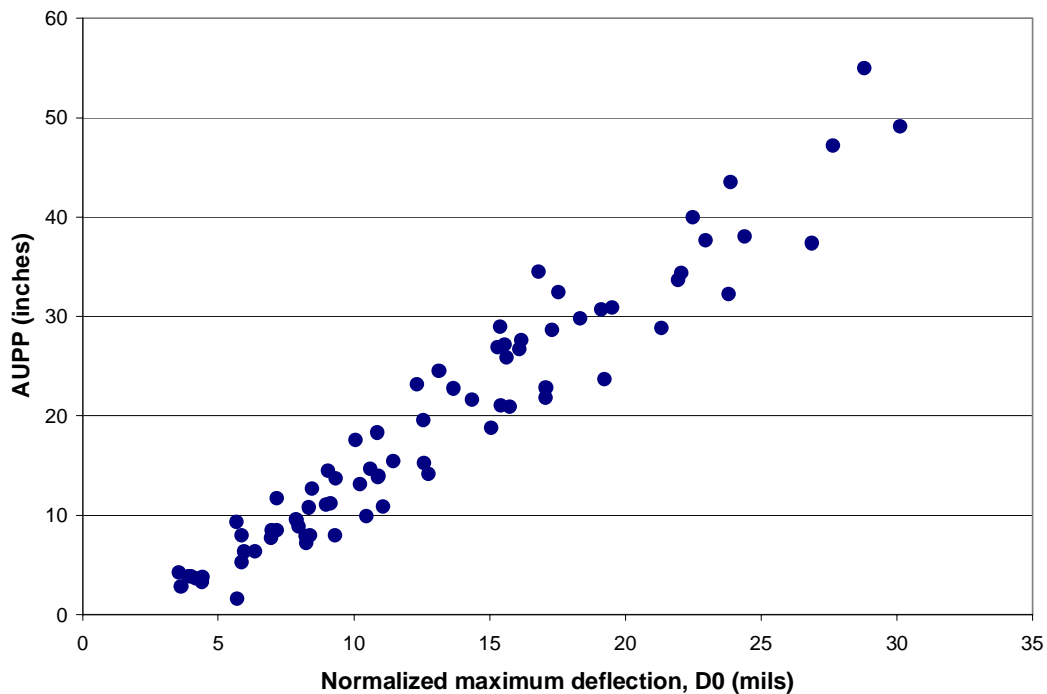
Figure 6. Maximum deflection versus AUPP, SPS-3 sites.

- Maximum deflection and AUPP are strongly correlated, as shown in Figure 6.
- Neither maximum deflection nor AUPP correlates very well to deflection basin AREA. This latter parameter is a measure of the relative stiffness of the pavement structure's stiffness versus the foundation's stiffness.
- Neither maximum deflection nor AUPP correlates very well to SN calculated from layer thicknesses and assumed structural coefficients. This should not be too surprising, for at least two reasons. First, SN calculated from layer thicknesses and material properties does not reflect the effect of past traffic, whereas AUPP and maximum deflection, calculated from wheelpath deflections, ostensibly do. Second, SN applies to the pavement layers above the subgrade, whereas AUPP and maximum deflection are influenced by the stiffness of the subgrade as well.

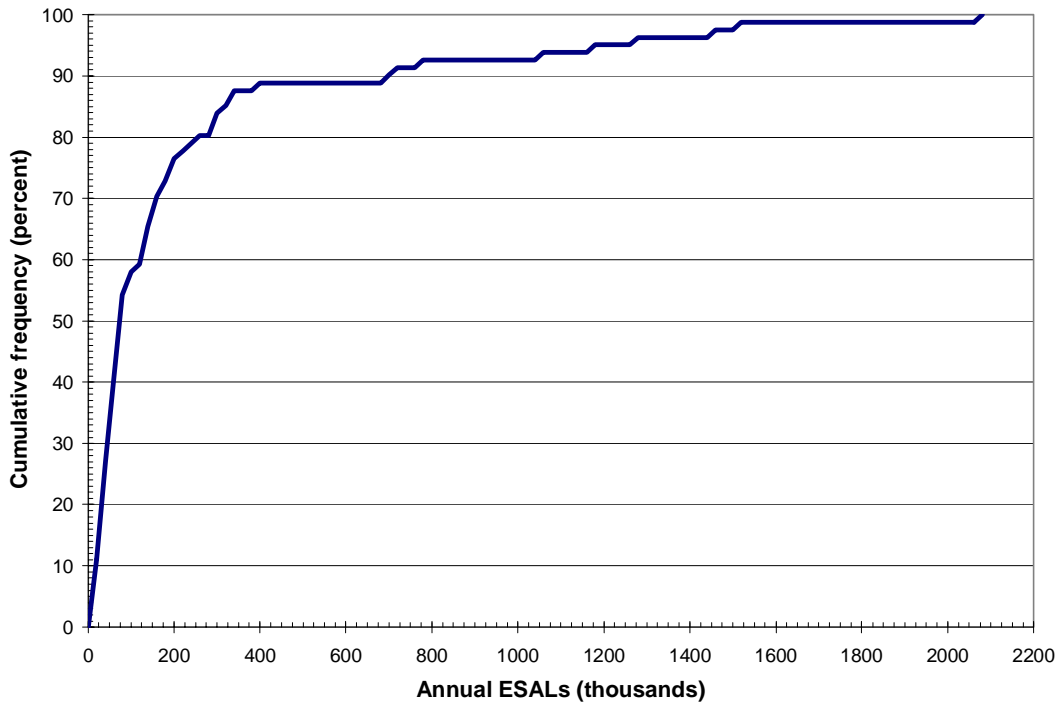
Figure 7. Cumulative frequency distribution of 1990 annual ESAL levels at SPS-3 sites.

The annual ESAL levels calculated for the year 1990 are shown by SPS-3 site in Appendix A. The cumulative frequency distribution of 1990 annual ESAL levels is shown in Figure 7. The annual traffic level in 1990 was fairly low for nearly all of the SPS-3 sites: less than about 50,000 ESALs for 33 percent of the sites, and less than about 150,000 ESALs for 67 percent of the sites.

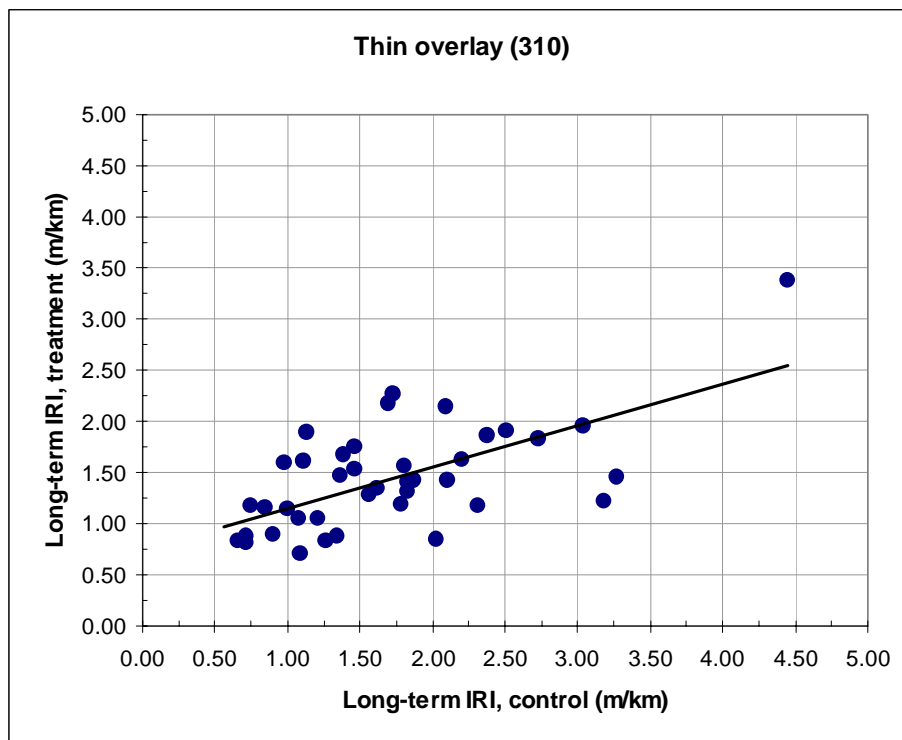
Figure 13. Long-term IRI, SPS-3 thin overlay versus control.

The results indicate that of the four maintenance treatments in the core SPS-3 experiment, only the thin overlays had long-term IRI values significantly different than the corresponding control sections. This is illustrated in Figure 13.

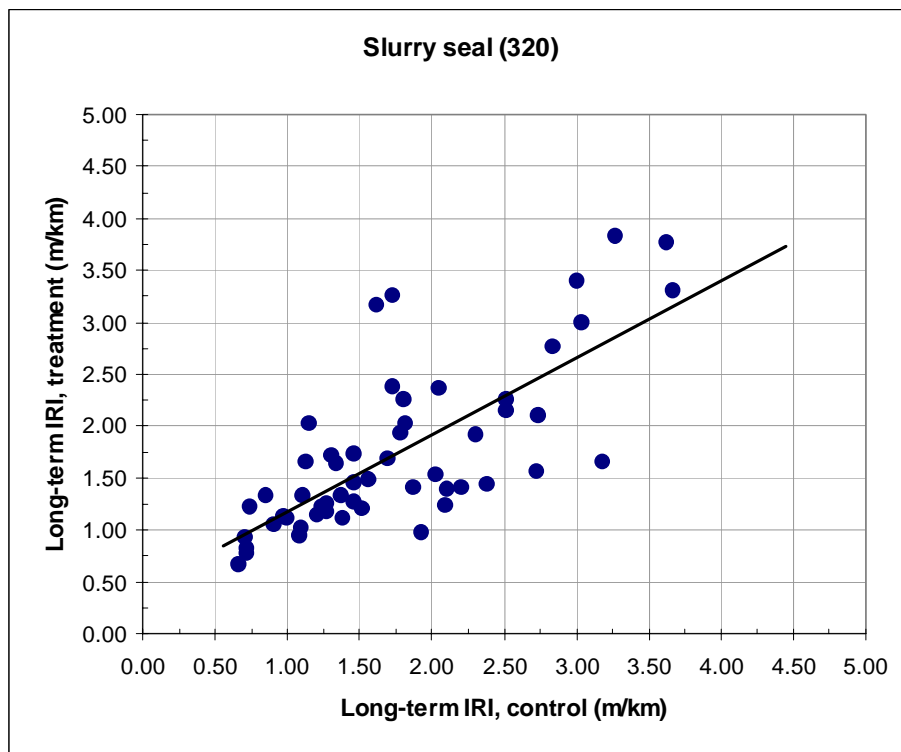
Figure 14. Long-term IRI, SPS-3 slurry seal versus control.

Plots of the long-term IRI values in the treated sections versus the control sections are shown in Figures 14, 15, and 16 for the slurry seal, crack seal, and chip seal treatments respectively. The second most influential treatment appears to be the chip seal treatment (Figure 16), although the mean difference (0.7 m/km) was not found to be statistically significant.

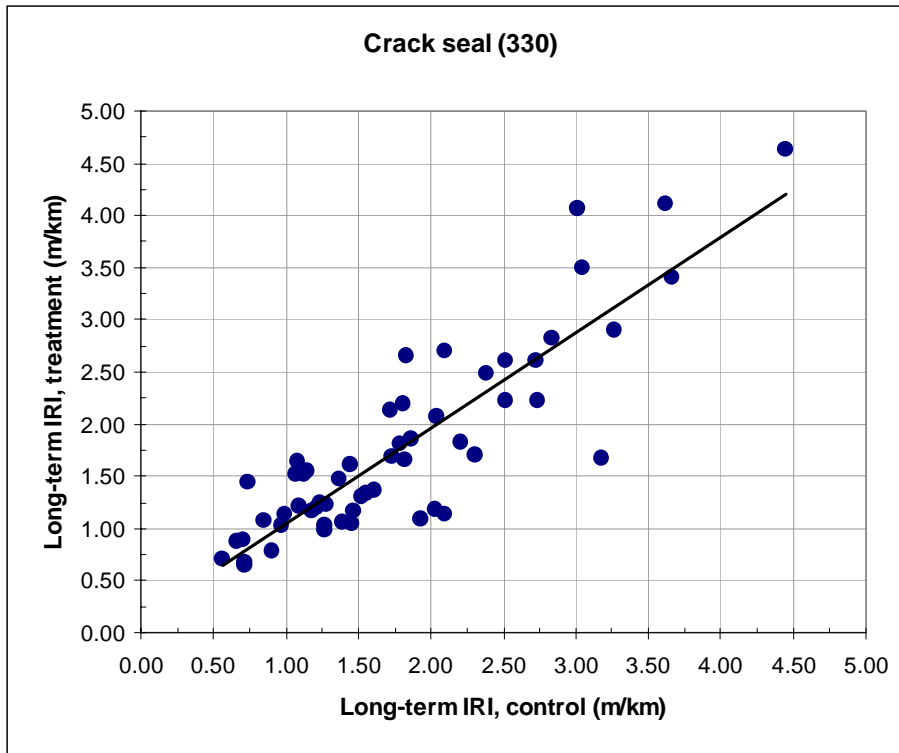
Figure 15. Long-term IRI, SPS-3 crack seal versus control.

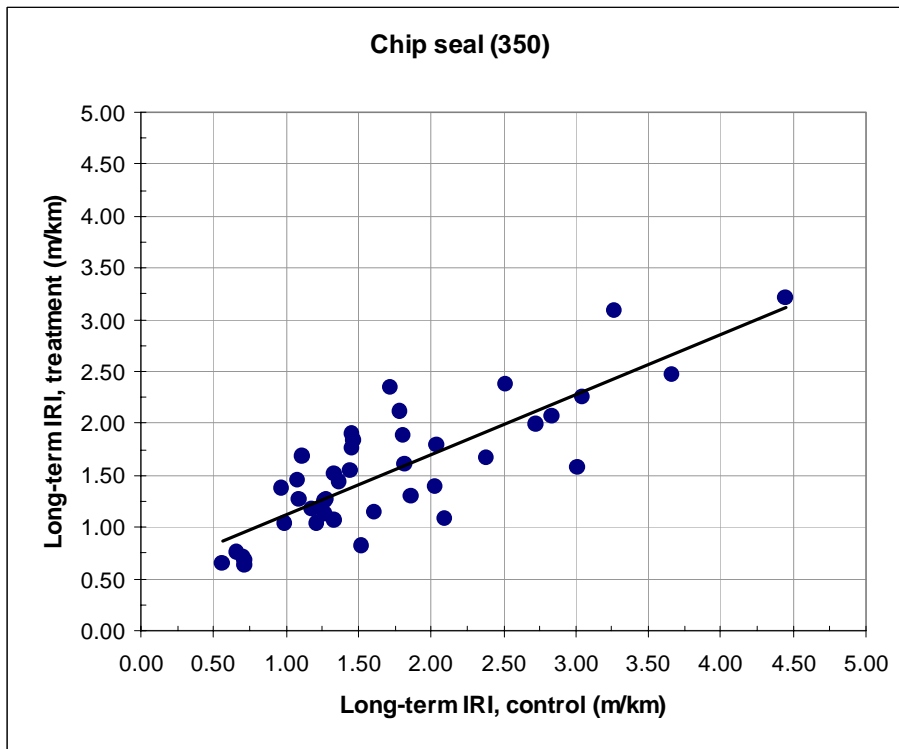
Figure 16. Long-term IRI, SPS-3 chip seal versus control.

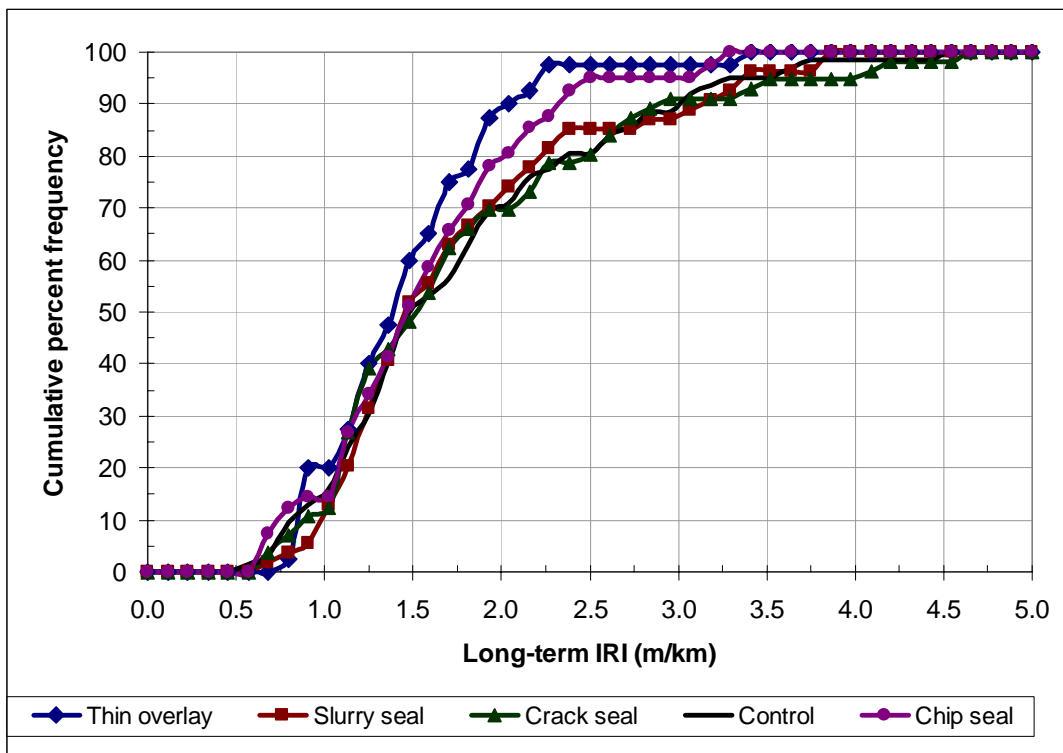
Figure 17. Cumulative frequency distributions of long-term IRI, SPS-3 treatments.

However, looking at not only the fiftieth percentile values but the complete distributions, it appears that not only the thin overlay distribution but also the chip seal distribution are fairly consistently to the left of the control distribution, especially at IRI levels above about 1.75 m/km. The slurry seal and crack seal distributions, on the other hand, follow the control distribution very closely. These results reinforce the impression that the chip seal treatment was the second most effective, after the thin overlay treatment, in reducing long-term roughness.

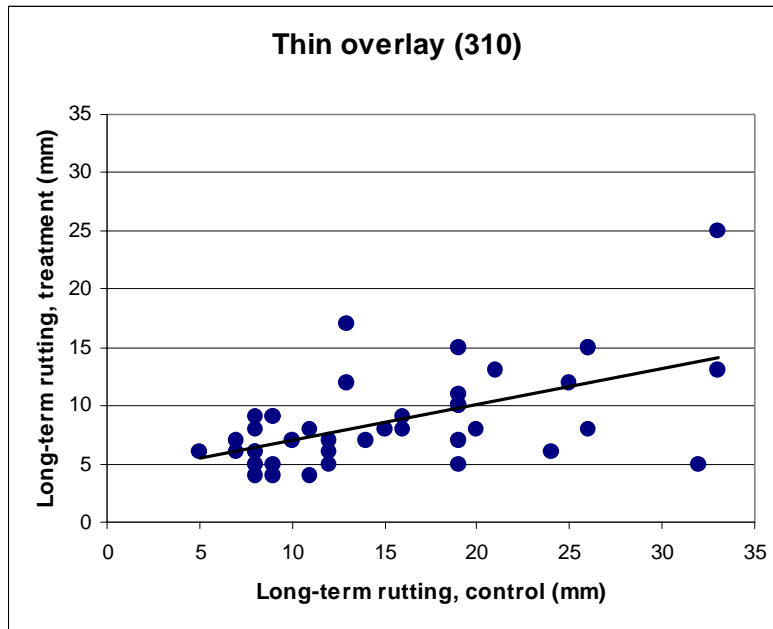
Figure 18. Long-term rutting, SPS-3 thin overlay versus control.

Only in the comparison between the thin overlays and the corresponding control sections was a significant mean difference detected in long-term rutting. Plots of the long-term rutting values in the thin overlay, slurry seal, crack seal, and chip seal sections versus the control sections are shown in Figures 18 through 21 respectively.

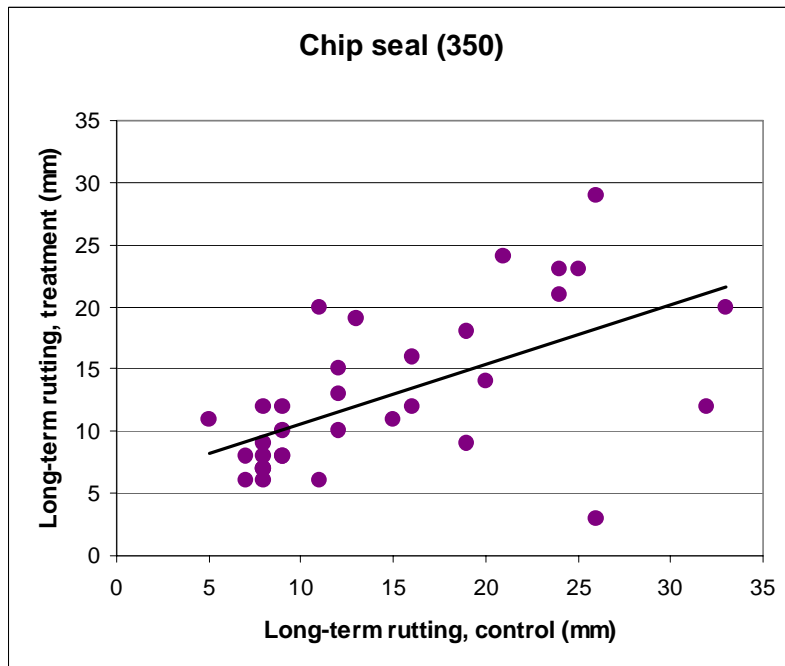
Figure 21. Long-term rutting, SPS-3 chip seal versus control.

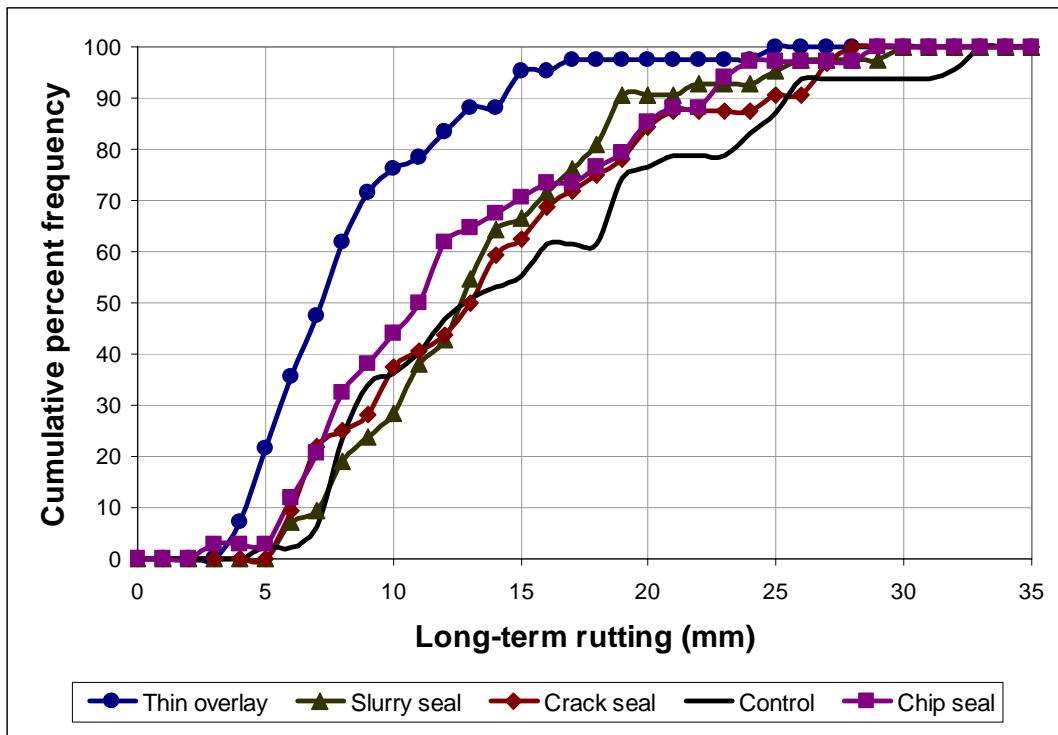
Figure 22. Cumulative frequency distributions of long-term rutting, SPS-3 treatments.

The cumulative frequency distributions of long-term rutting are shown for the four treatment groups and the control group in Figure 22. As this plot shows, the thin overlay distribution is clearly to the left of the control and all of the other distributions. At lower rutting levels, the distributions of the other three treatments follow the control distribution fairly closely. However, at rutting levels greater than about 12 mm, the slurry seal, crack seal, and chip seal distributions are also fairly consistently to the left of the control distribution. The frequency distributions reinforce the impression that thin overlays were most effective at reducing long-term rutting, followed by the other three maintenance treatments.

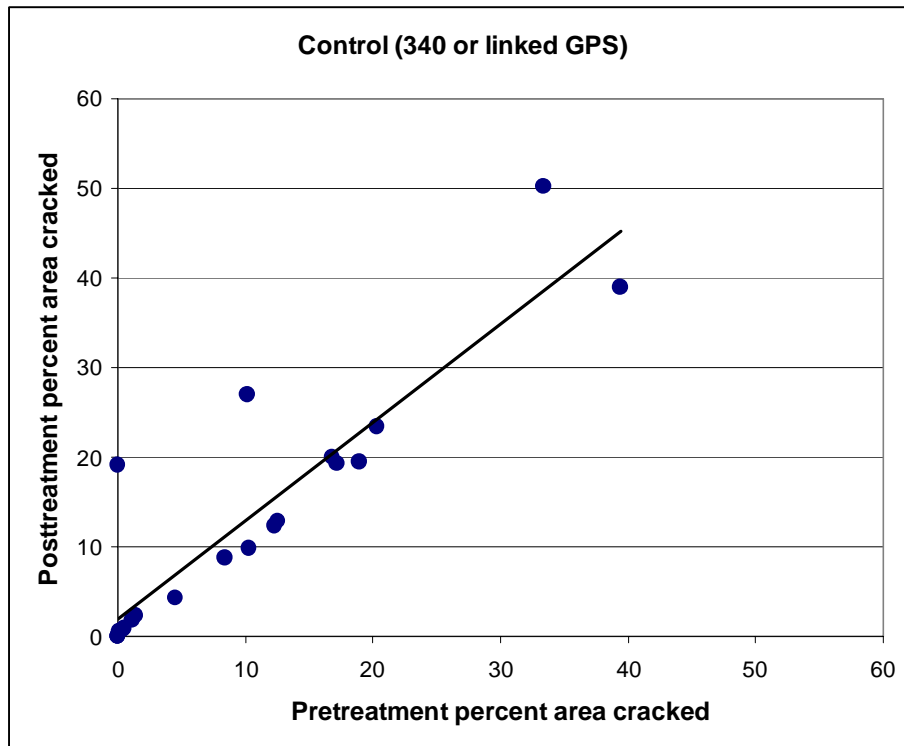
Figure 23. Fatigue cracking before and after treatment date, SPS-3 control sections.

A plot of percent area fatigue cracked in the control section before and after the date of treatment of the adjacent sections is shown in Figure 23. In most sections, the cracking recorded shortly after the treatment date is the same or slightly more than that recorded prior to the treatment date. In a few sections, the amount of cracking recorded changed considerably.

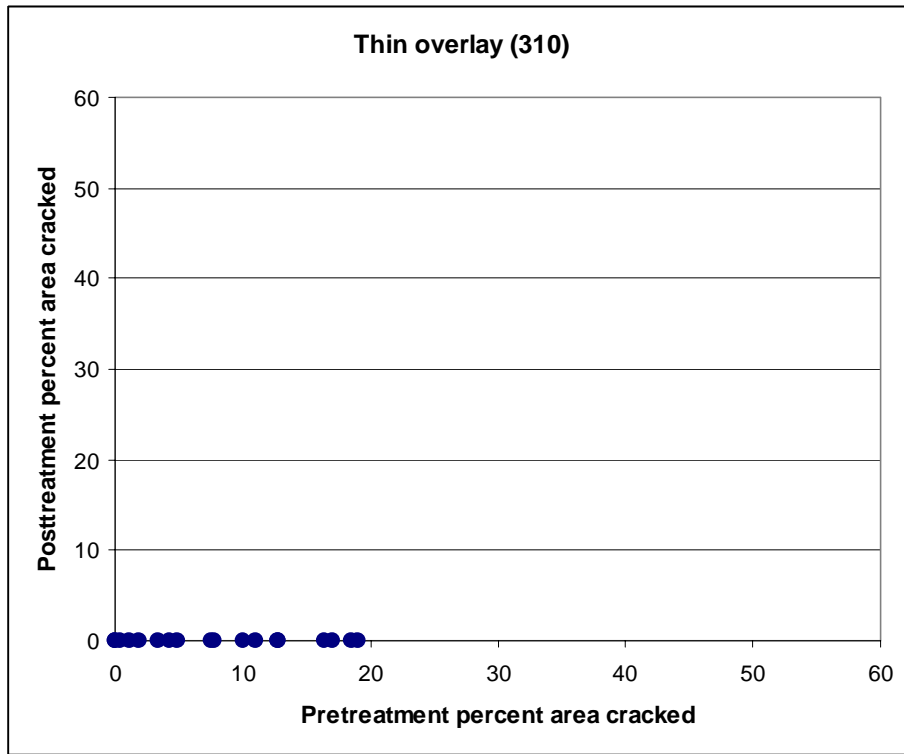
Figure 24. Fatigue cracking before and after treatment, SPS-3 thin overlay sections.

Plots of cracking before and after treatment are shown for the thin overlay sections, slurry seal sections, crack seal sections, and chip seal sections in Figures 24 through 27. It is obvious that cracking immediately after treatment in the thin overlay, slurry seal, and chip seal sections was zero or nearly zero, whereas cracking in the crack seal sections was in nearly every case equal to or greater than the pretreatment cracking level.

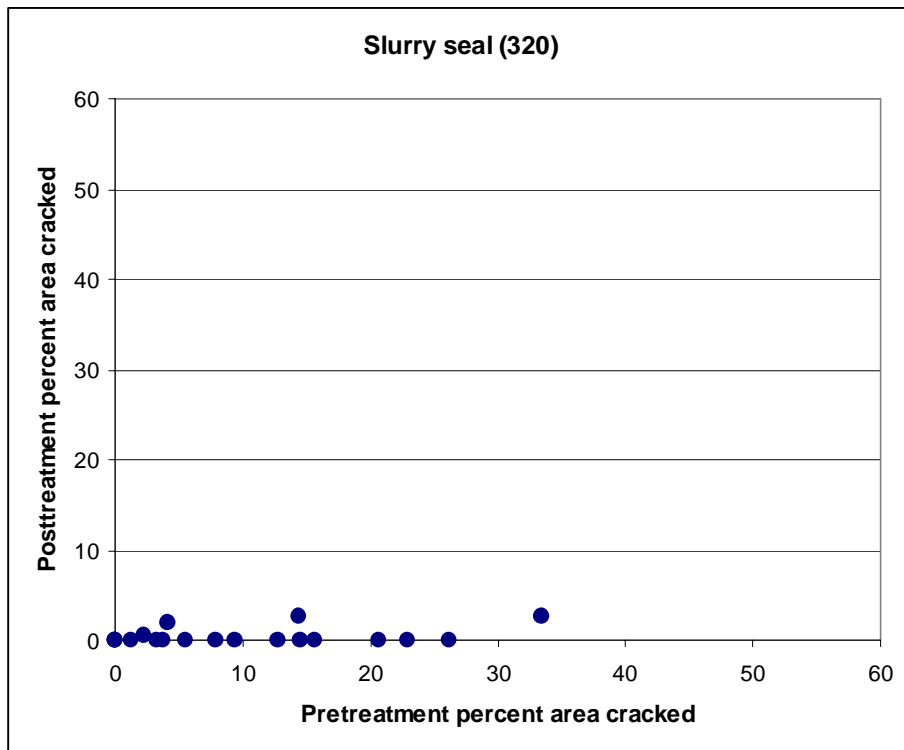
Figure 25. Fatigue cracking before and after treatment, SPS-3 slurry seal sections.

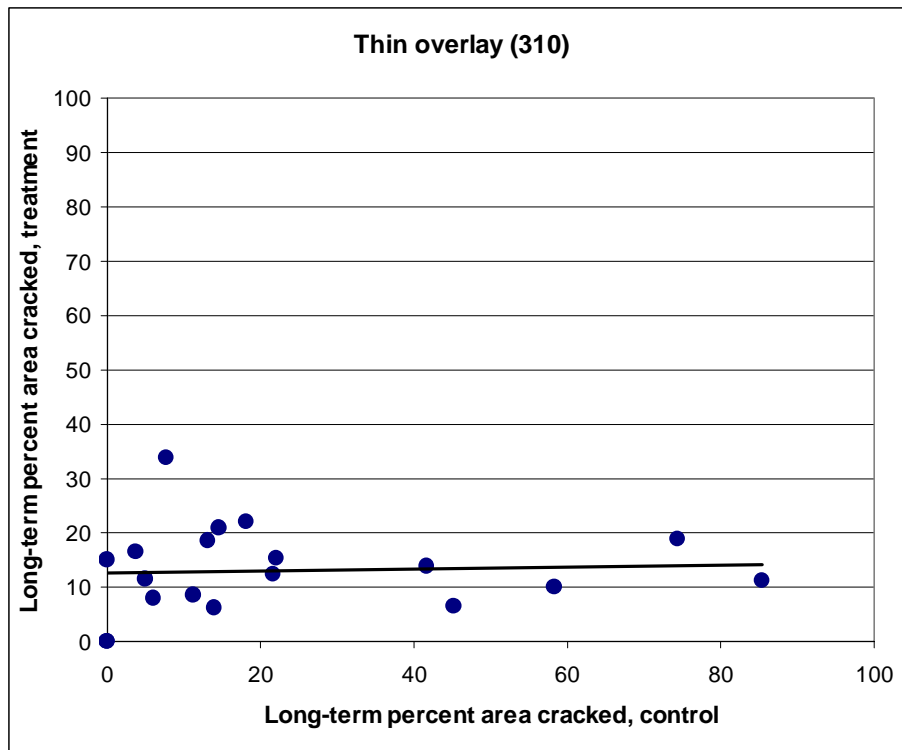
Figure 28. Long-term fatigue cracking , SPS-3 thin overlay versus control.

A plot of percent area fatigue cracked in the thin overlay sections versus their corresponding control sections is shown in Figure 28. The rather remarkable result is that fatigue cracking is fairly consistent among almost all of the thin overlay sections considered in this analysis. The trendline is very close to horizontal, and the average area cracked is 13 percent (according to the calculation method described previously).

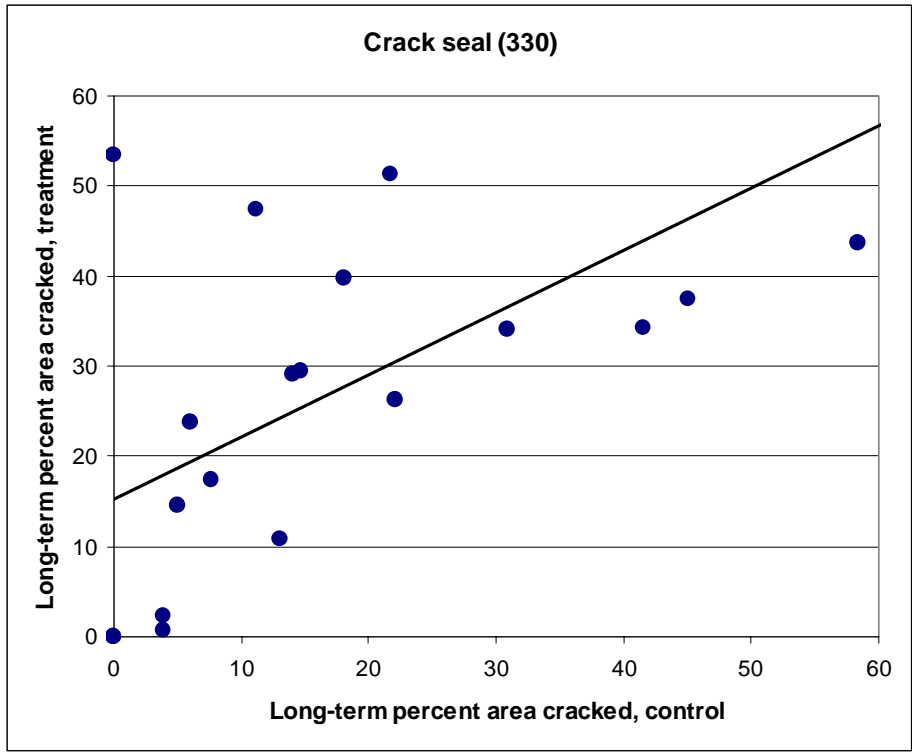
Figure 30. Long-term fatigue cracking , SPS-3 crack seal versus control.

The situation in the crack seal sections is very different, as Figure 30 shows. For all but a few sections, the fatigue cracking in the crack seal section is greater than in the control section, and in some cases considerably greater. Again, it is conceivable that this is not due to any true adverse effect of crack sealing on the fatigue life of the pavement, but rather (1) the sealing of new cracks (that is, cracks that appeared after the initial treatment date) in some crack seal sections but not in the corresponding control sections, and/or (2) the greater visibility of sealed cracks.

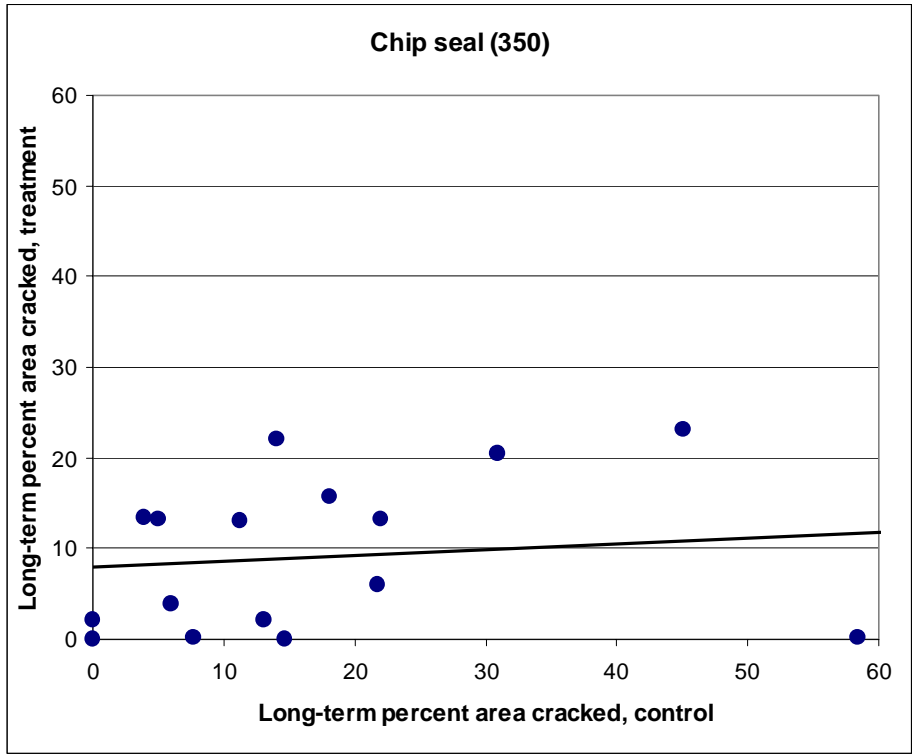
Figure 31. Long-term fatigue cracking , SPS-3 chip seal versus control.

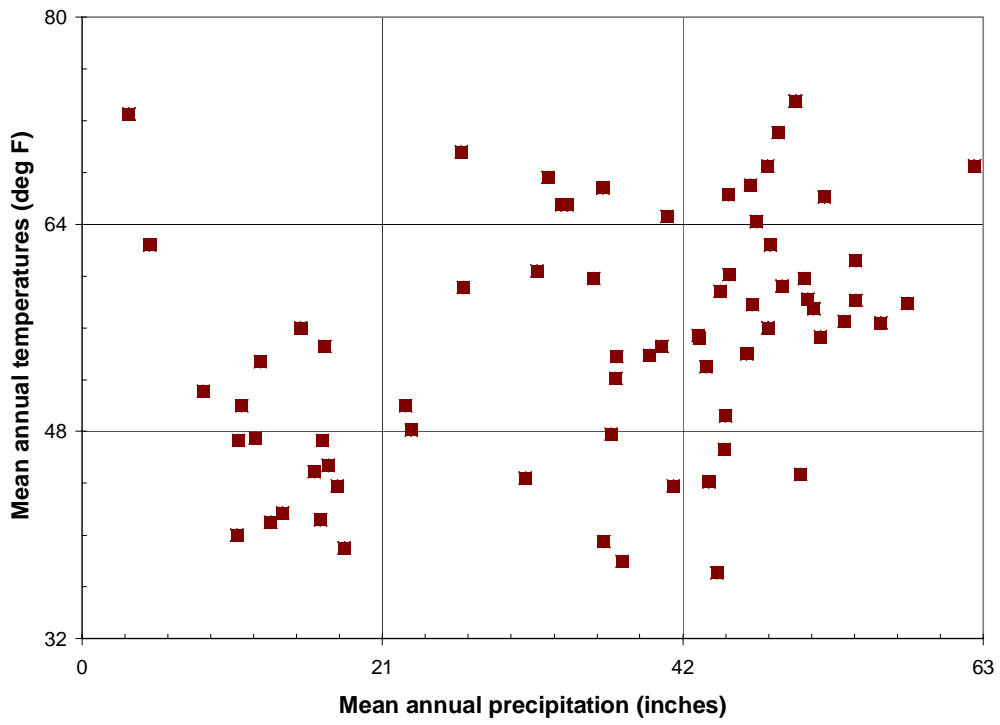
Figure 34. Distribution of GPS-6B sites with respect to precipitation and temperature.

The climatic distribution of the SPS-5 and GPS-6B sites was determined by extracting the latitude and longitude for each site from the LTPP database, searching the National Oceanic and Atmospheric Administration (NOAA) database for the weather station nearest the SPS-5 or GPS-6B site, and extracting the 30-year average annual precipitation and average annual temperature for the weather station. These data are provided in Appendix B. The distributions of SPS-5 sites and GPS-6B sites with respect to average annual precipitation and temperature are illustrated in Figures 33 and 34 respectively. Not shown in Figure 34, and not considered in the subdivision of the precipitation range, are three GPS-6B sites in Alaska with total annual precipitation in excess of 95 inches.

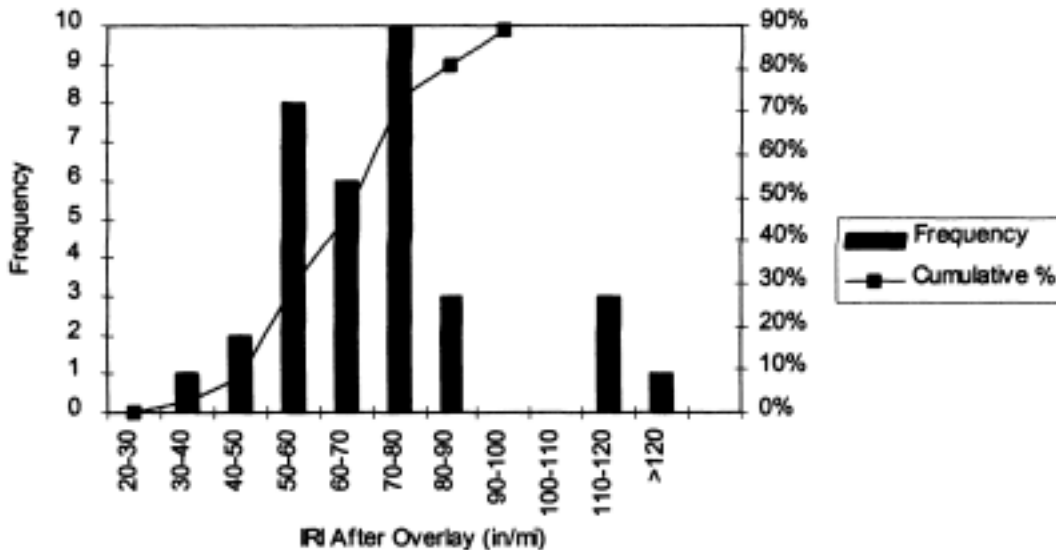
Figure 38. Frequency distribution of postoverlay IRI values for GPS-6B sections, 1997 analysis.<sup>21</sup>

A frequency distribution of the postoverlay IRI values for the 37 GPS-6B projects with profile data available in 1997 is shown in Figure 38. The GPS-6B sections were no more than five years old at the time of the analysis. As these sections had thus far exhibited little if any change in IRI, it was considered too soon to conduct any statistical analysis of IRI trends.

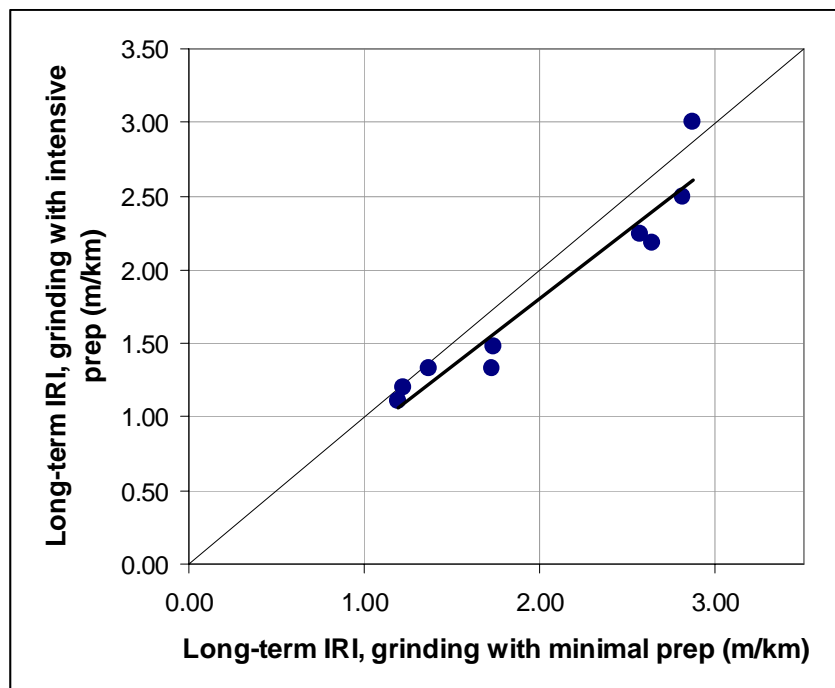
Figure 84. Long-term IRI, SPS-6 minimal versus intensive nonoverlay rehabilitation with grinding.
