# **NCHRP**

## **REPORT 564**

### **Field Inspection of In-Service FRP Bridge Decks**

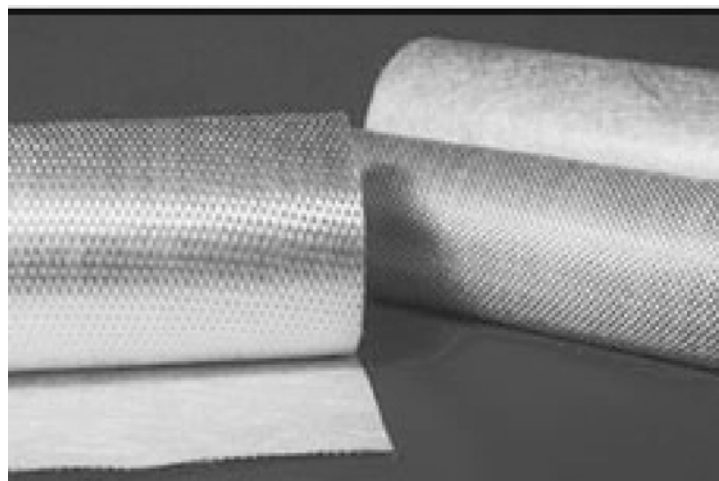
Mats may be produced as either continuous- or chopped-strand mats. A chopped-strand mat is produced by randomly depositing chopped strands onto a plate, then tacking them to each other using a small amount of binder. A continuous-strand mat is produced similarly, but without chopping. The resulting mat has better strength characteristics than a chopped mat. Figure 2.3.1.2-4 shows typical fabric rolls of mat.

**Figure 2.3.1.2-4 Chopped strand mat fabric.**

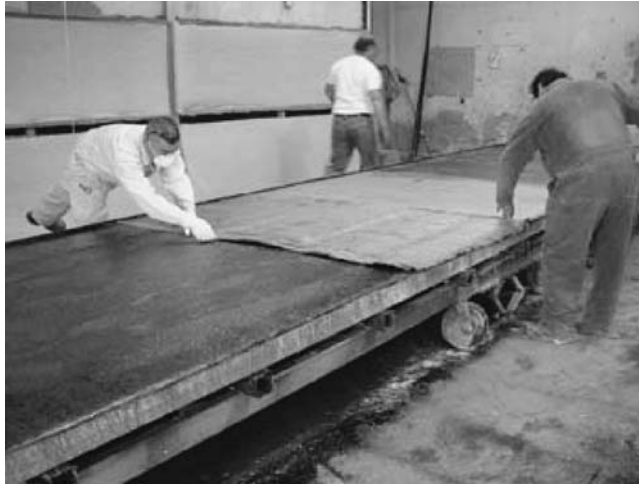
The hand lay-up process is the most fundamental method of manufacturing still widely used in all industries. The basic procedure is shown in Figures 3.5.1-1 and 3.5.1-2. Fiber reinforcement is placed in position on the mold or plate and then saturated with resin. A crew then uses specialized rollers and paddles to work the resin into the fabric, fully wetting the layer. After determining that the layer is fully wetted, the crew repeats the process on succeeding layers until the lamination is complete. The component is then left to cure thoroughly, which takes from a few hours to overnight.

**3.5.1-1 Hand lay-up operation: dry filament placement.**

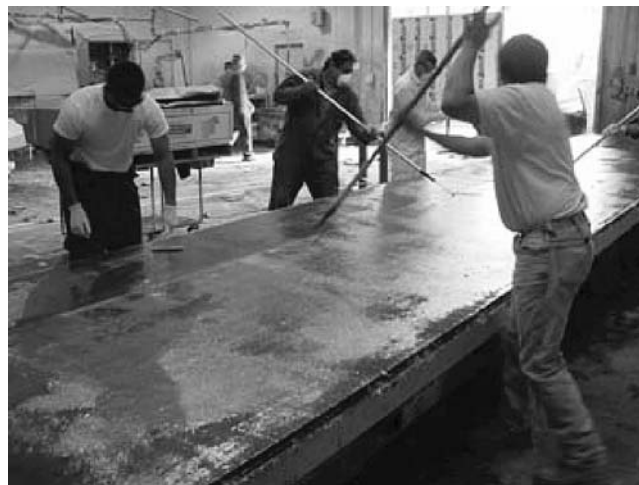
**3.5.1-2 Hand lay-up operation: fabric saturation.**

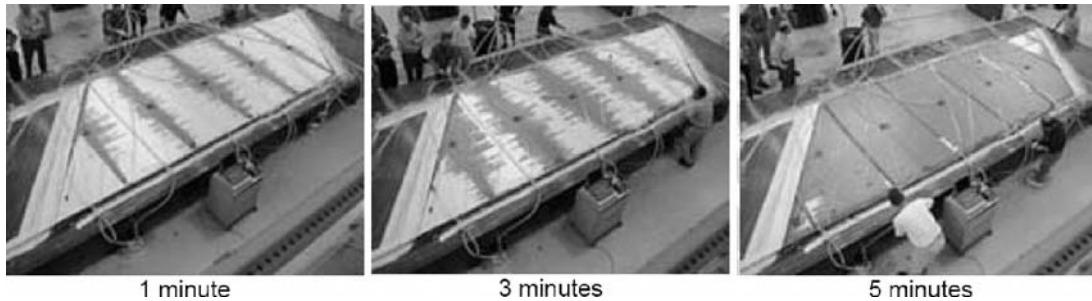
The VARTM method employs a soft bag over the part to seal the mold so that a vacuum can be drawn under the bag. Once vacuum is achieved, the part is pressed onto the hard tool by atmospheric pressure. Resin ports on feed tubes are then opened to permit resin to flow into the mold and infiltrate the dry fabric reinforcement, as shown in Figure 3.5.2-1.

**Figure 3.5.2-1 Vacuum infusion process on Tycor reinforced bridge deck.**

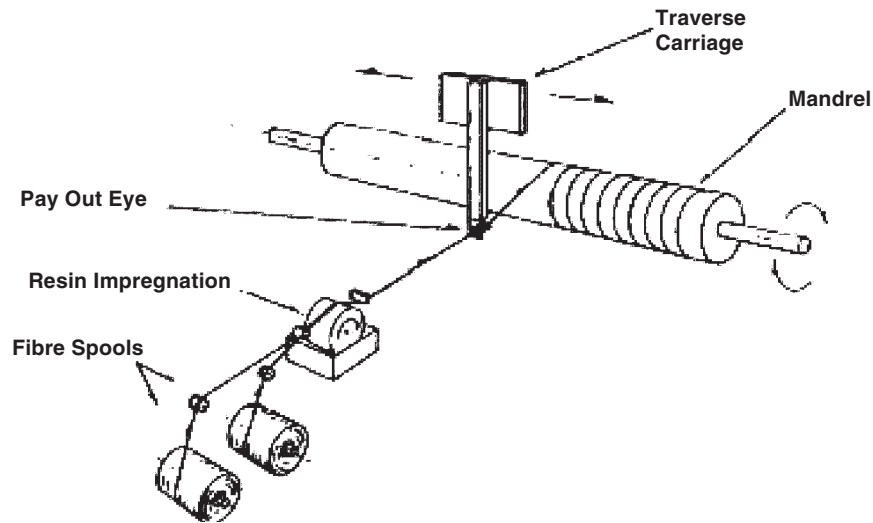
Filament winding is the process of fabricating FRP components by wrapping wet roving or fabric onto a single-axis rotating mandrel as shown in Figure 3.5.4-1. While no FRP bridge decks or components now in field service are being fabricated by the filament winding process, research and development of the process for fabricating deck components have been ongoing in the United States and Canada. For example, the University of Illinois completed NCHRP-IDEA Project 63, “Manufacture and Testing of a Filament Wound Composite Bridge Superstructure,” demonstrating that filament wound bridge components could be fabricated at the 1/10th scale size.

**Figure 3.5.4-1 General schematic for filament winding process**  
(from [www.tifac.org.in/news/acfil.htm](http://www.tifac.org.in/news/acfil.htm)).

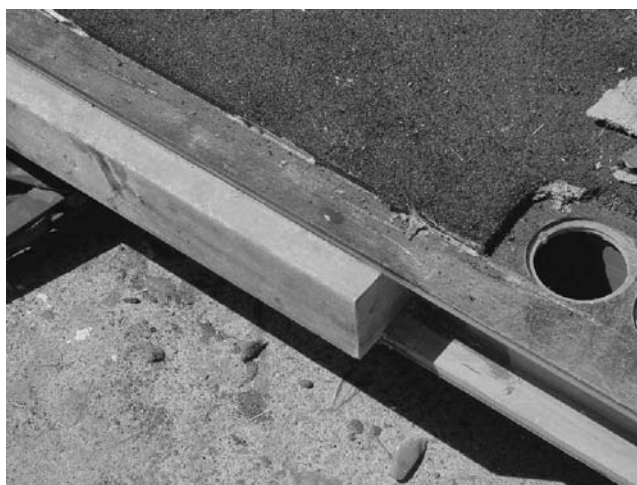
Another example is the shear key connection used on the Schuyler Heim deck shown in Figure 3.7.3.1.1-2. This is a secondary bonded shear key made with an FRP-wrapped wood core and bonded to the C-section of the adjacent deck edge. The exposed faces are lathered with epoxy adhesive and bonded into place during installation.

**Figure 3.7.3.1.1-2 Shear key on Schuyler Heim decks.**

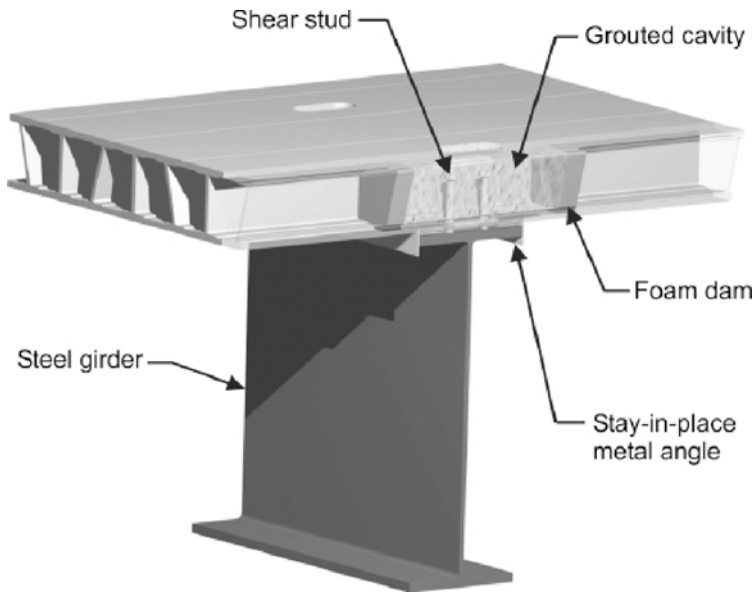
**Figure 3.7.3.2.1-1 Typical shear stud connections.**

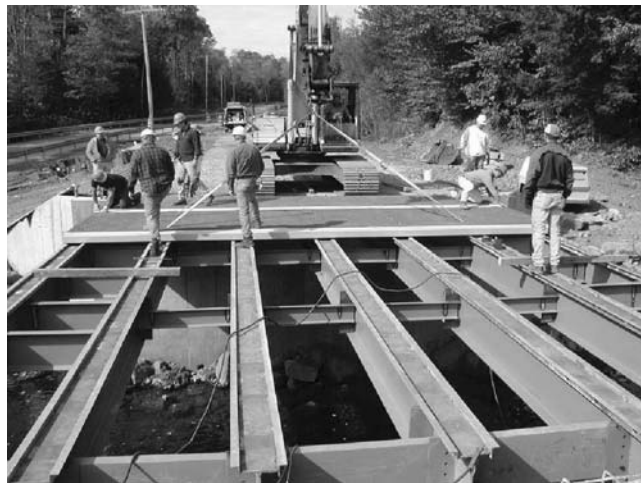
To take up the irregularities between the girders and deck, a haunch is typically built up by flowing grout beneath the decks into the cavity between the top of the girder and bottom of the deck. The preparation of this is as shown in Figure 3.7.3.2.1-2.

**Figure 3.7.3.2.1-2 - Deck being laid down on steel girders; note the channel formed on the top flange for casting haunches.**

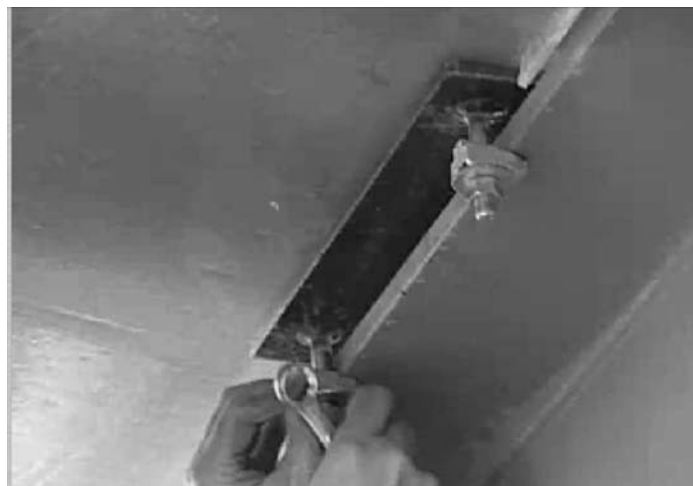
**Figure 3.7.3.2.3-2 Girder clips for Jay Street Bridge.**

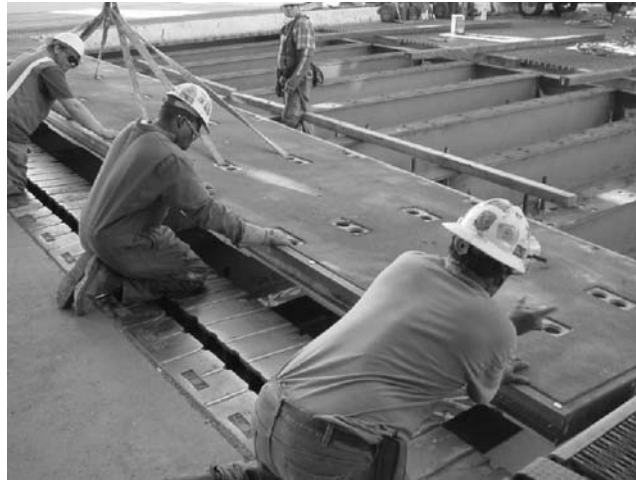
**Figure 3.7.3.2.4-1 Carbon/fiberglass deck being installed in the Schuyler Heim lift bridge.**

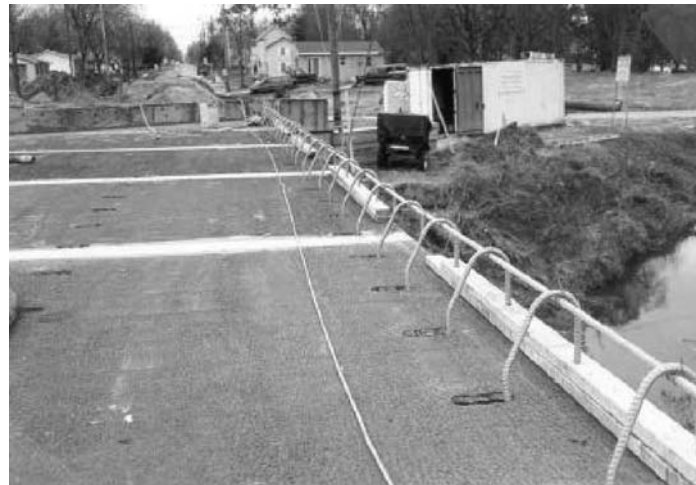
**3.7.5.1-2 Reinforcing anchor details for the cast-in-place curb.**

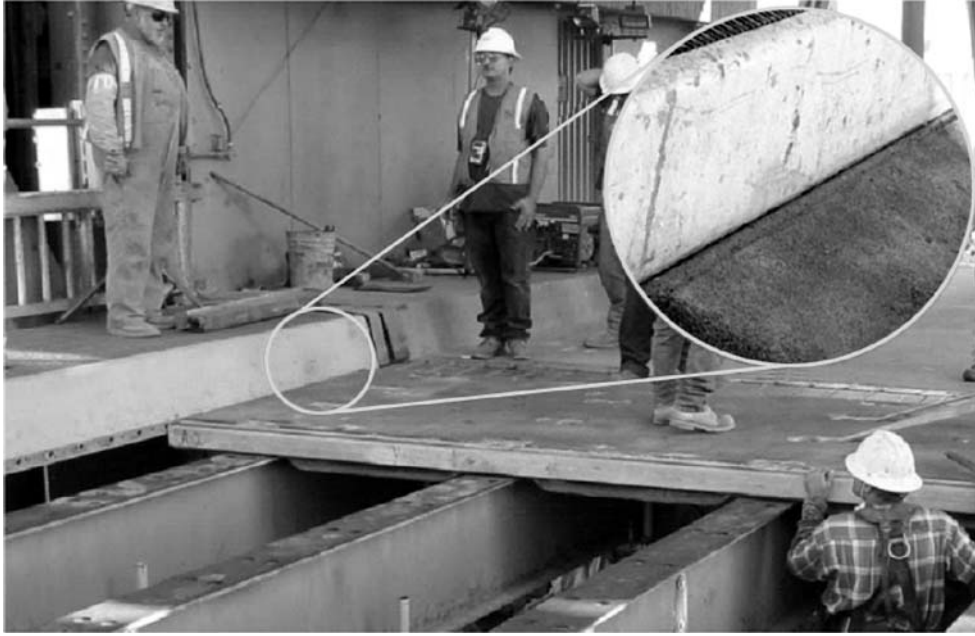
On some bridges, curbs and railings are designed to be independent of the FRP decks. In these installations, the curbs and railings are connected to independent superstructure components or fascia girders. This type of construction helps to eliminate lateral loads being applied to the FRP decks, thereby making the FRP deck and the connection less susceptible to direct damage from vehicular or other type of lateral impact loads. Figure 3.7.5.2-1 illustrates this type of connection where the curbs, sidewalk, and railings are attached independently to stringers and separated by a gap from the FRP (as shown in the inset).

**Figure 3.7.5.2-1** Curb and sidewalk adjacent but not connected to the FRP deck.

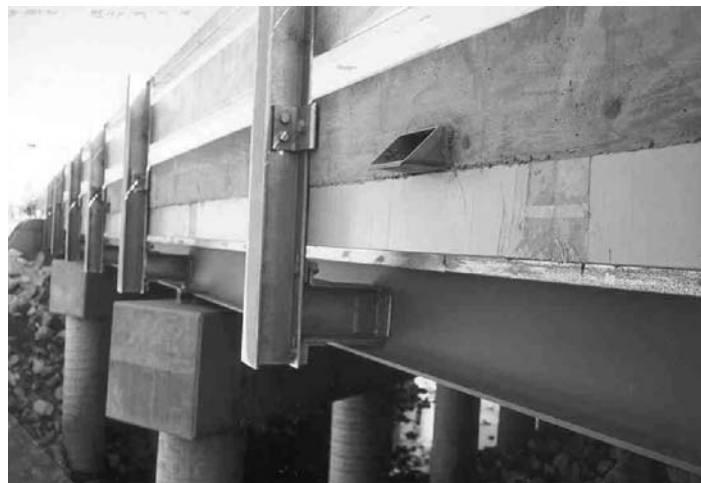
On many FRP deck bridges, the railings are connected to independent fascia beams or girders but are also indirectly connected to the FRP decks. In these types of construction, the curbs are typically built on the FRP deck as discussed in an earlier section, while the railings abut the curbs but are connected directly to a fascia girder. Therefore, the girders resist all loads on the railings, while both the girders and the deck resist loads on the curbs. An example of this type of construction is illustrated in Figure 3.7.5.3-1.

**Figure 3.7.5.3-1** Figure showing railing connected to the curb and the fascia girder.

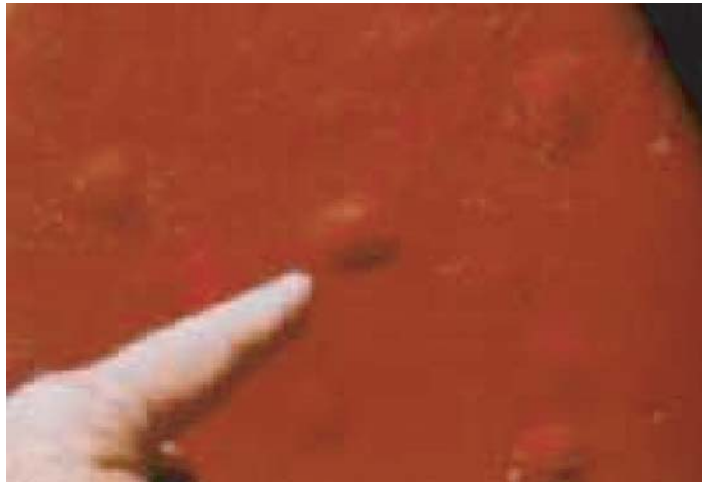
Blistering appears as surface bubbles on exposed laminate surfaces or gelcoated surfaces as shown in Figure 4.4.1-1. In the marine industry, blisters are generally attributed to osmosis of moisture into the laminate that exerts local hydrostatic pressure between layers, causing delamination and subsequent bubbling. This is normally a problem for marine craft because of the thinness of the shell. In FRP deck panels, osmosis to a degree that would cause blistering is rare. Trapped moisture subjected to freeze-thaw cycles could possibly cause this phenomenon, but it would most likely affect only the surface layer and not impact the deck's structural performance.

**Figure 4.4.1-1 Blistering on a gelcoated or laminated surface.**

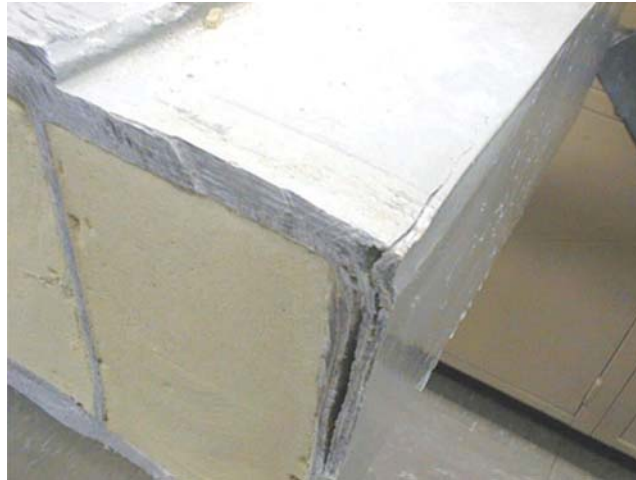
VOIDS are submerged gaps within the laminates of a deck and are usually invisible if the composite laminate resin is pigmented or the surface is painted or gelcoated. If the void is large enough and grows progressively, it may appear as a crack on the surface. An example of this is shown in Figure 4.4.2-1 where the closeout of a foam-filled deck contained a large void that revealed itself as a surface crack along the closeout's edge.

**Figure 4.4.2-1 Internal voids in a closeout section of a foam-filled deck.**

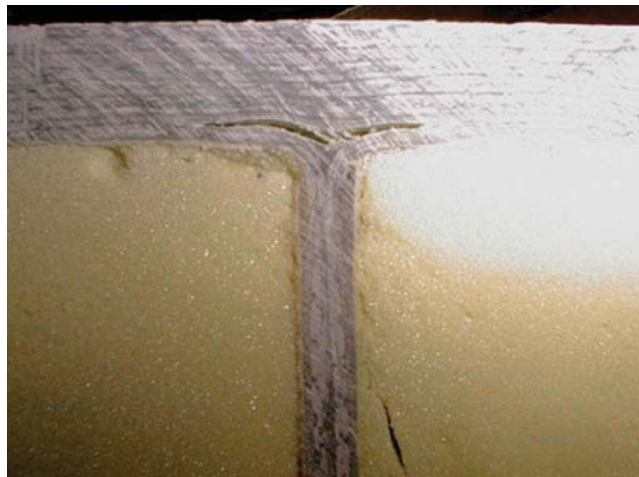
More commonly, voids would be hidden and become the site where delamination begins over time. An example of a severe void is shown in Figure 4.4.2-2. The deck manufacturer's process and quality-assurance procedures are expected to prevent large voids that would degrade deck performance. Detection of such voids goes beyond visual inspection and can only be accomplished with signal penetration instruments.

**Figure 4.4.2-2 Manufacturing void found in the facesheet of a foam-filled deck.**

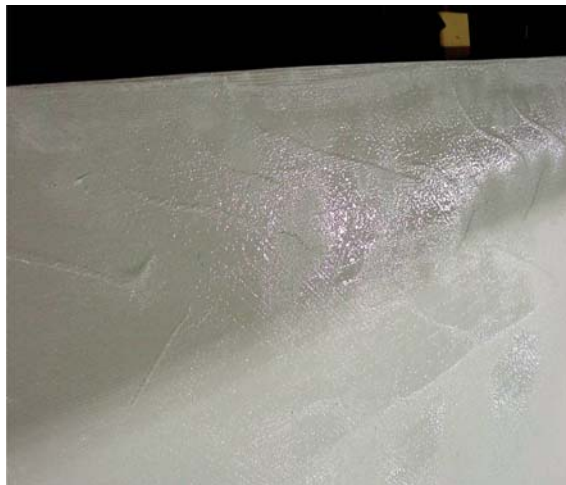
Fabric wrinkling is shown in Figure 4.4.4-1 and generally occurs because of excessive stretching or shearing of the fabric during wet-out. It is not a structural problem unless it interferes with the proper surface contact at the connection or impedes the bonding of the wear surface.

**Figure 4.4.4-1 Fabric wrinkling in laminated facesheet.**

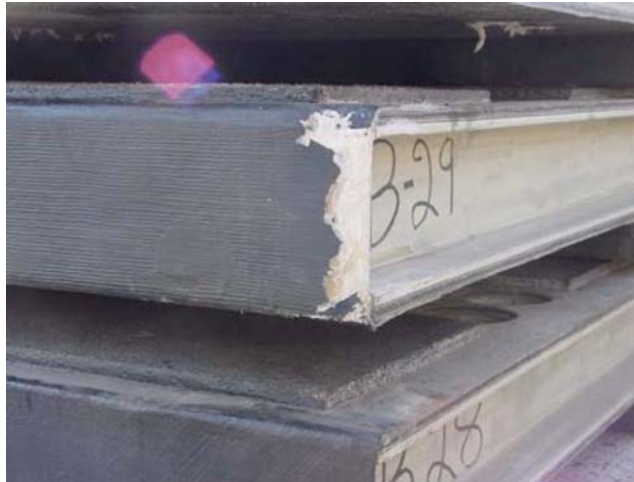
In this damage scenario, the laminate exhibits fiber brooming or environmental exposure because of prior damage in handling as shown in Figure 4.4.5-1. Left unattended, the damage would make the fibers susceptible to moisture and contamination, leading to further laminate deterioration in the area.

**Figure 4.4.5-1 Exposed fiberglass fibers from installation damage.**

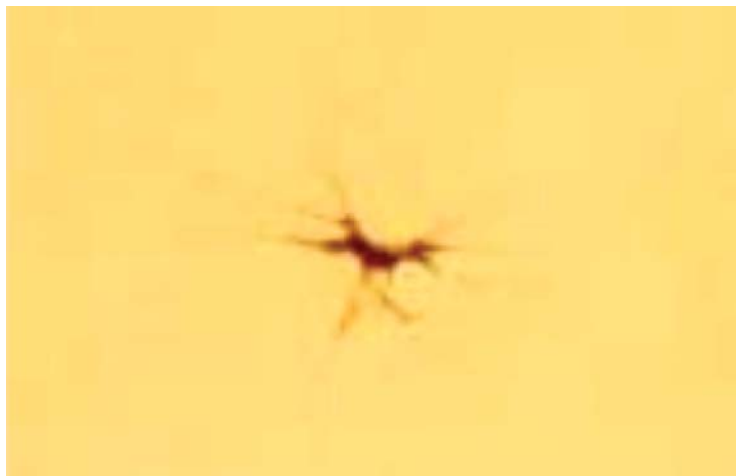
Damage due to impact can result in cracks on the facesheet emanating from the point of impact. Impact cracks are caused by impact from vehicles, debris, or stones, and they typically result in separation of material through the entire thickness of the laminate. Sometimes failure at a location with insufficient reinforcement fibers can cause damage that looks like impact cracks. Other types of failure, such as punching, can also initiate cracks emanating from the edges of the punched area. Examples of impact cracks are shown in Figures 4.4.6-1 and 4.4.6-2.

**Figure 4.4.6-1 Example of impact-induced crack of facesheet.**

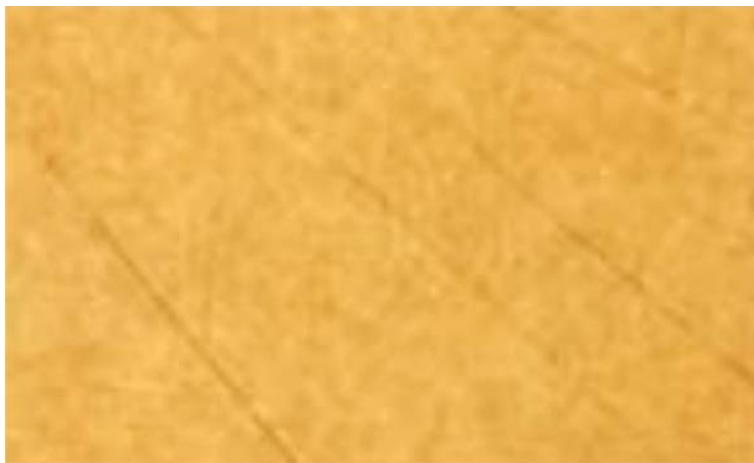
Facesheets can be abraded through improper handling in storage, during construction, with tools, and so forth, and this can result in scratches or shallow grooves on the FRP surfaces. These are usually just unsightly surface blemishes, but, if severe, they can develop into full-depth cracks under vehicular or environmental loads. Scratches are judged severe when the damage penetrates to the depth of the fiber and can lead to structural damage. An example of scratches is shown in Figure 4.4.7-1.

**Figure 4.4.7-1 Scratches on FRP surface.**

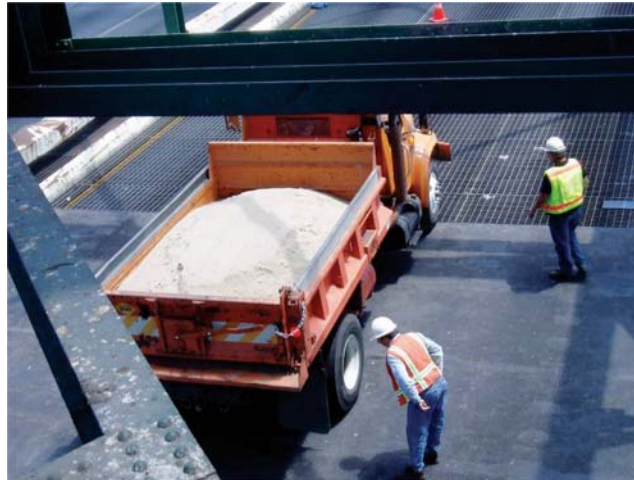
Blistering or debonding below the wear surface may be detected using VT (see expansion joint figure in Figure 5.2.1.1-2, which reveals subsurface debonding). However, to help detect defects or cracking that might otherwise go unnoticed with visual testing, a static or dynamic live-load test can be done in conjunction with VT. A loaded dump truck or water truck can be used (Figure 5.1.1-1) to help reveal cracks and undesirable vertical deck movement.

**Figure 5.1.1-1 Dump truck placed on deck to reveal any cracks in FRP deck.**

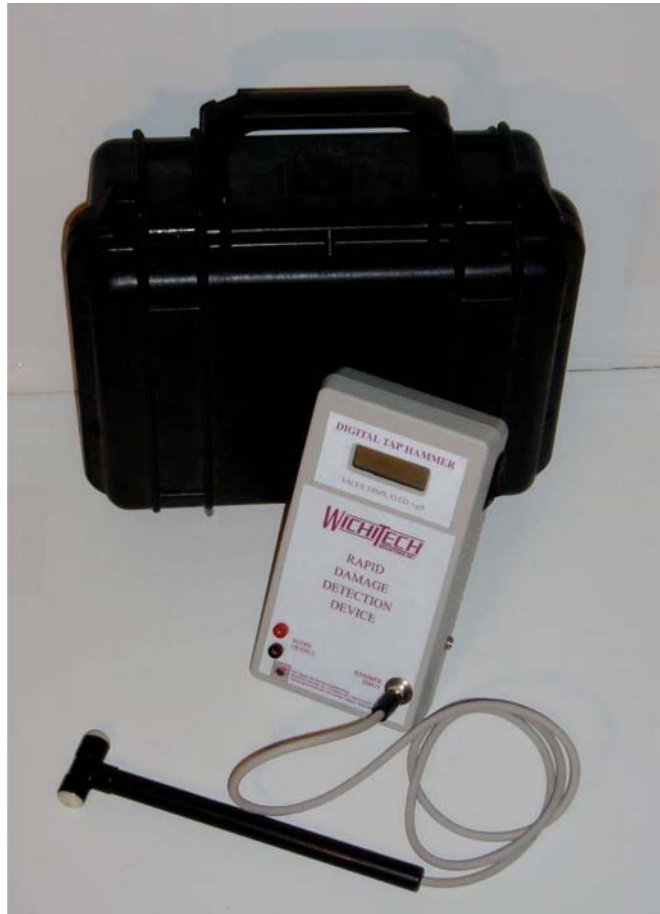
internal geometry. Instruments required for tap testing are a flashlight, a measuring tape, a straight edge, markers, and a large coin or small hammer.

**5.1.2-1 Electronic tap-tester unit.**

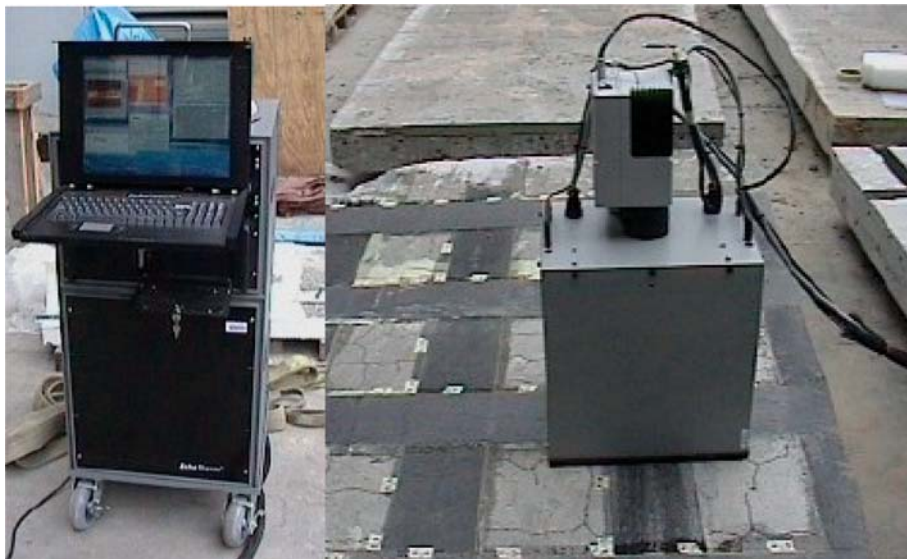
**Figure 5.1.3-2 Thermal wave image processing unit and IR camera/heat source provide high resolution of local area.**

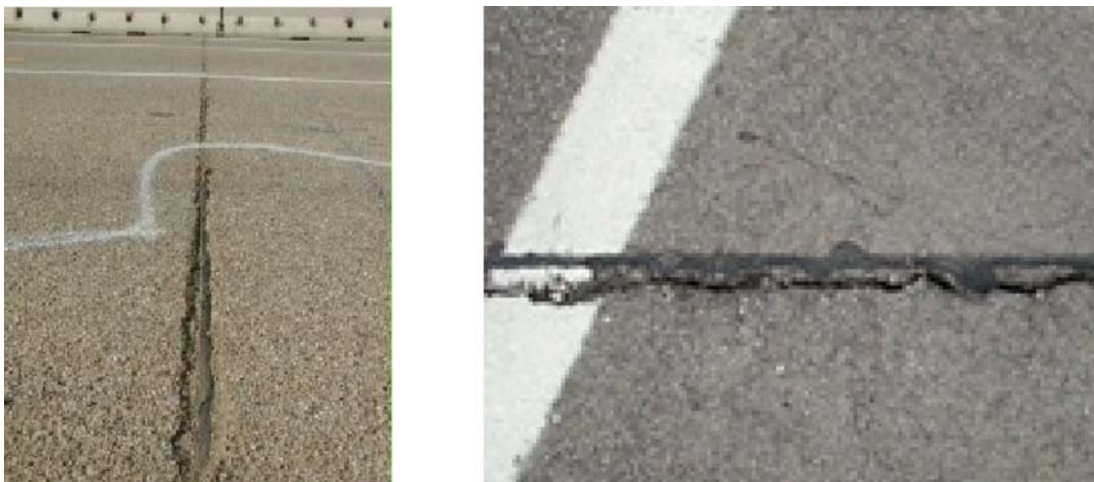
**Figure 5.2.1.1-1 Reflective cracking and oozed material at FRP deck-to-deck joints.**

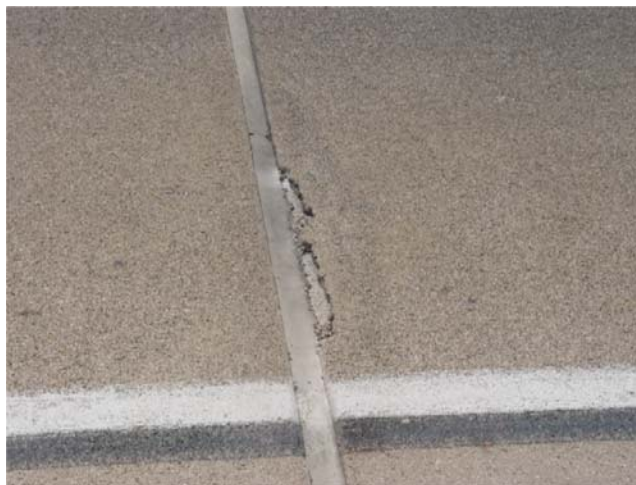
**Figure 5.2.1.1-2 Debonding at joint and below wear surface.**

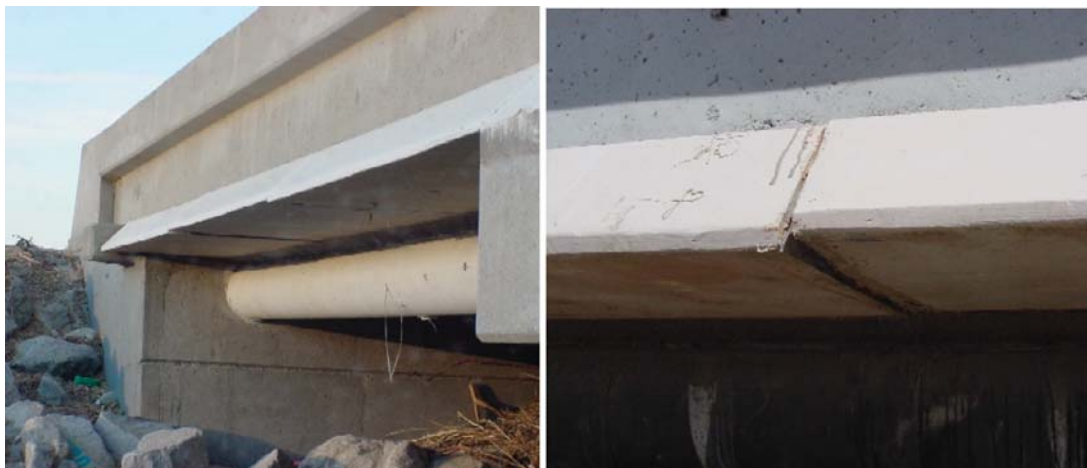
**Figure 5.2.1.1-3 Misalignment of deck-to-deck joint.**

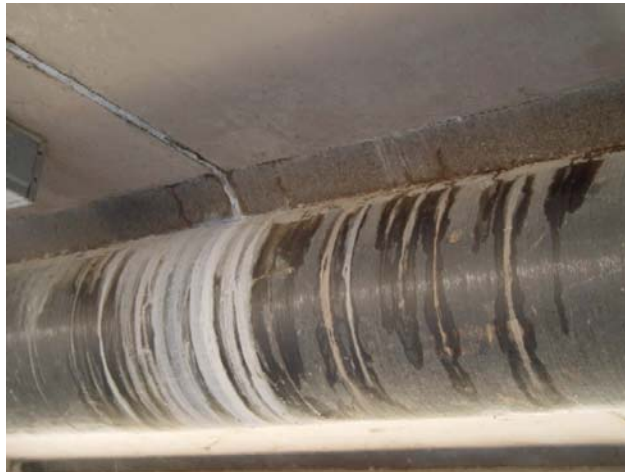
**Figure 5.2.1.1-5 Leakage through deck-to-deck joint.**

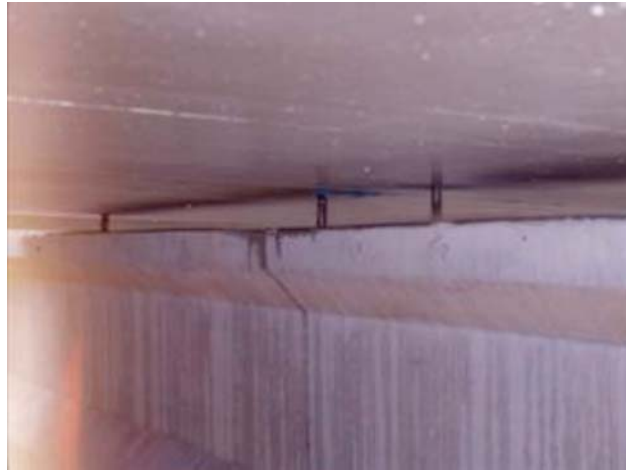
**Figure 5.2.1.2-1 FRP deck and connection studs.**

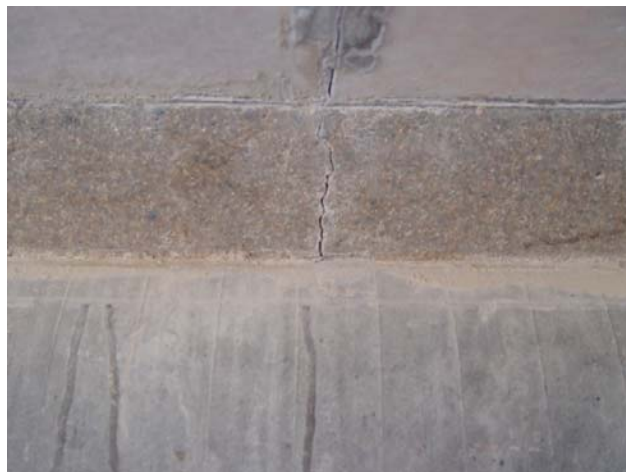
**Figure 5.2.1.2-3 Crack in haunch.**

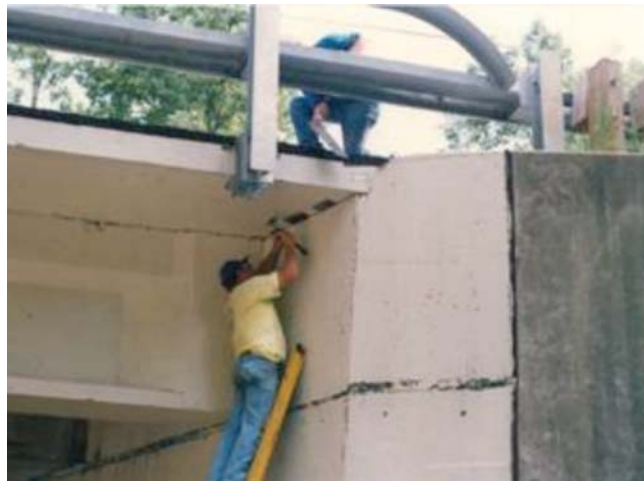
**Figure 5.2.1.3-1 Shimming of gap between deck and abutment.**

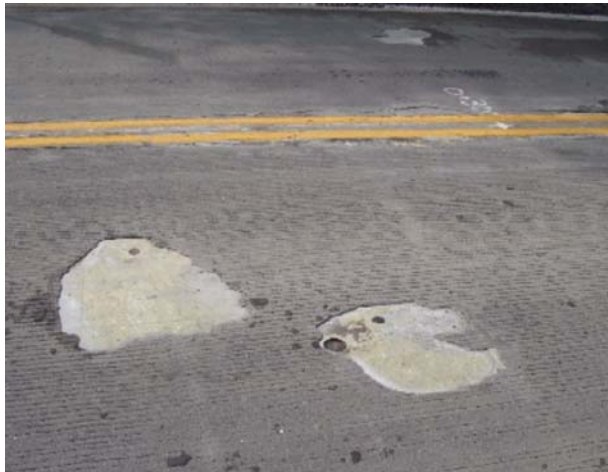
**Figure 5.2.1.4-1 Delamination/failure of wear surface on an FRP deck.**

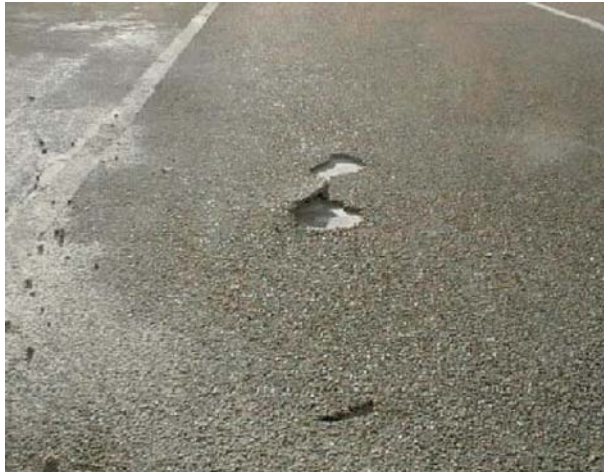
**5.2.1.4-2 Wear surface debonding.**

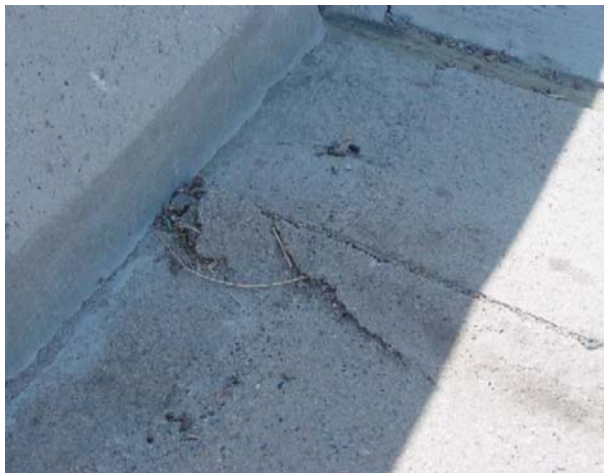
**Figure 5.2.1.4-3 Buckling of wear surface on FRP deck.**

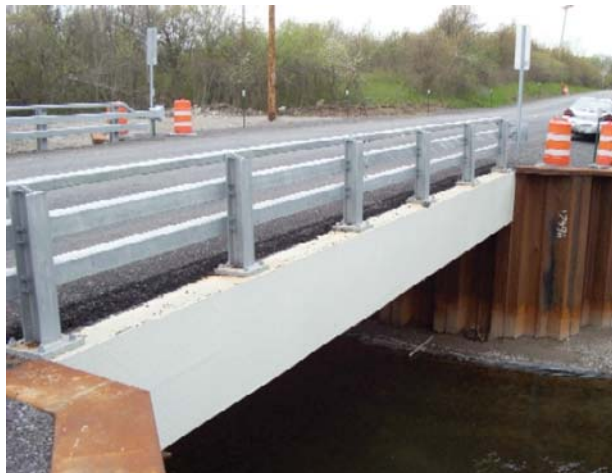
**Figure 5.2.1.5-1 Typical steel railing connected to FRP deck.**

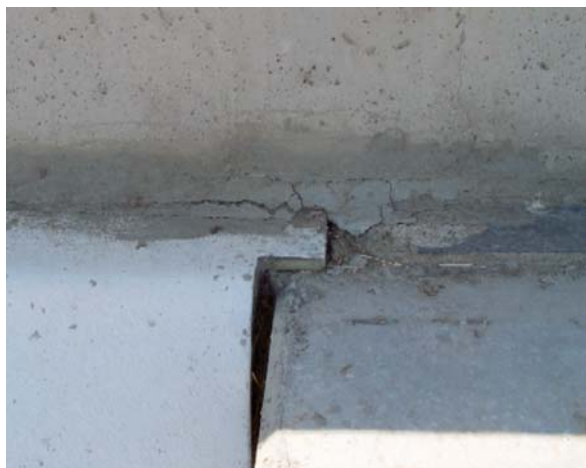
**Figure 5.2.1.5-4 Concrete cracking at the parapet-to-FRP-deck interface.**

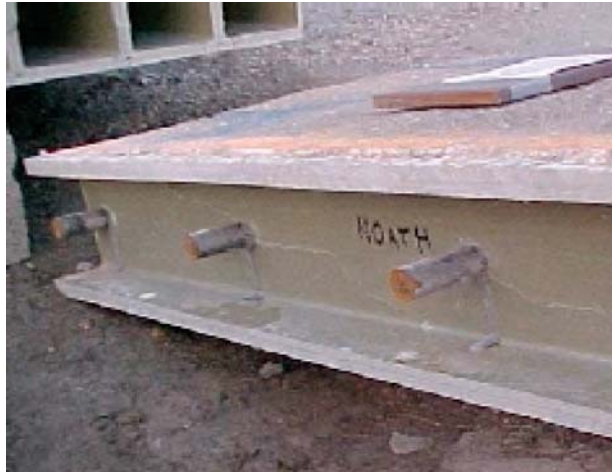
**Figure 5.2.1.5-5 Cracks in the web of FRP deck.**

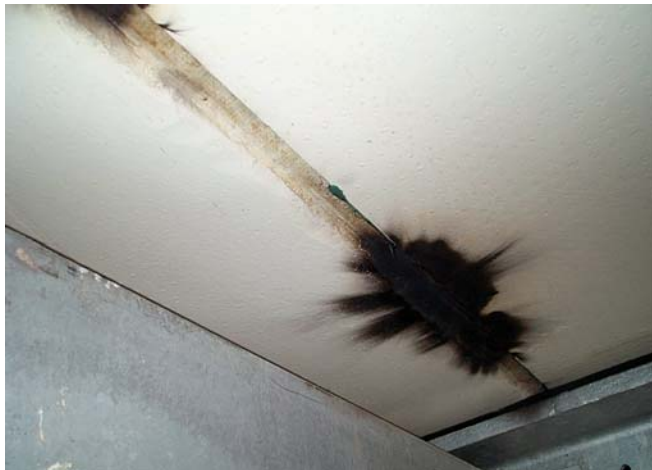
**Figure 5.2.2.1-4** Attempted ignition of deck material by vandals.

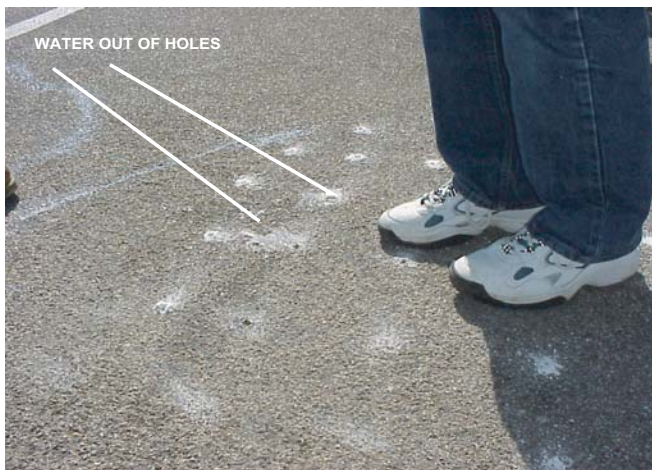
**Figure 5.2.2.1-5** Water found within core of deck after drilling.

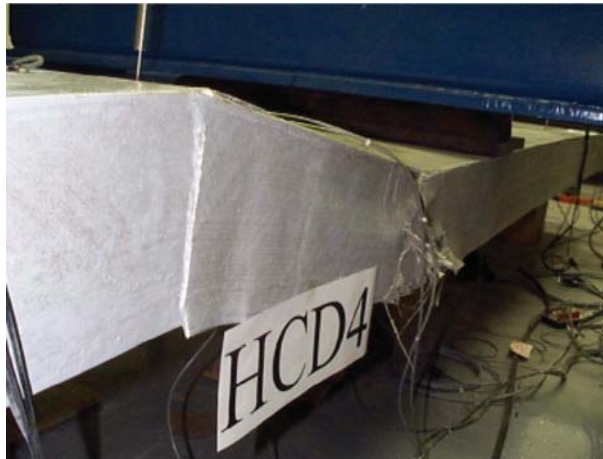
**Figure 5.2.2.2-1** Foam sandwich deck failure under line load.

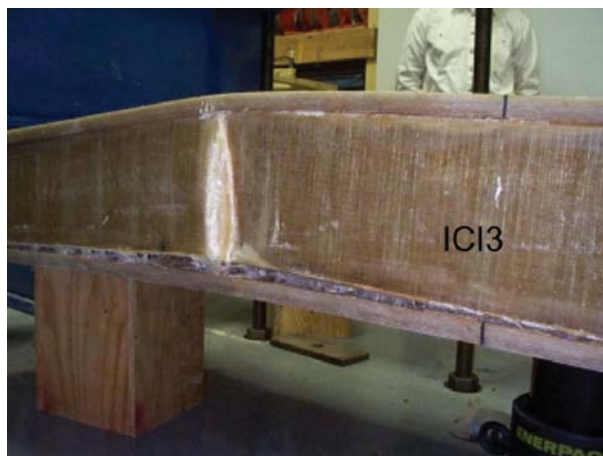
**Figure 5.2.2.2-2** Example of web failure and debonding of thick facesheet from core.

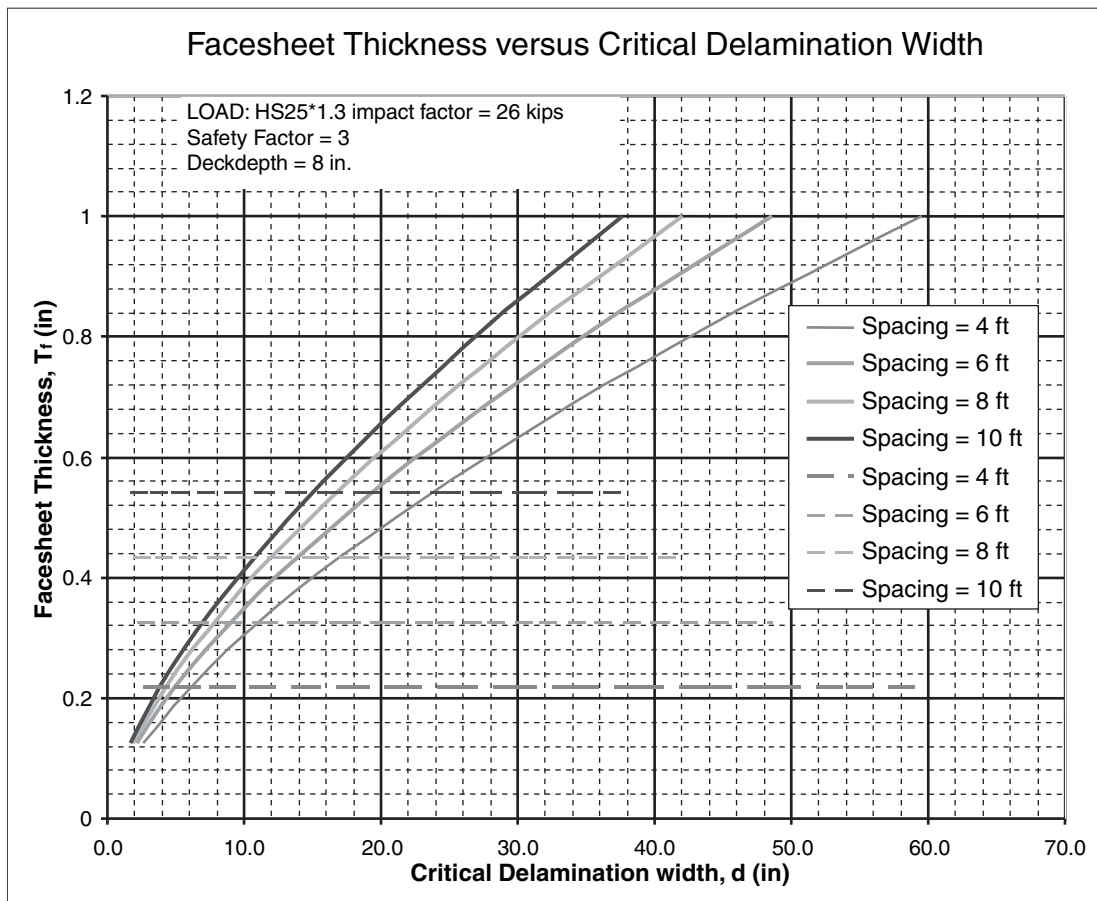
**Figure 7.1.2-1 Typical critical delamination sizes used for damage threshold derivations.**

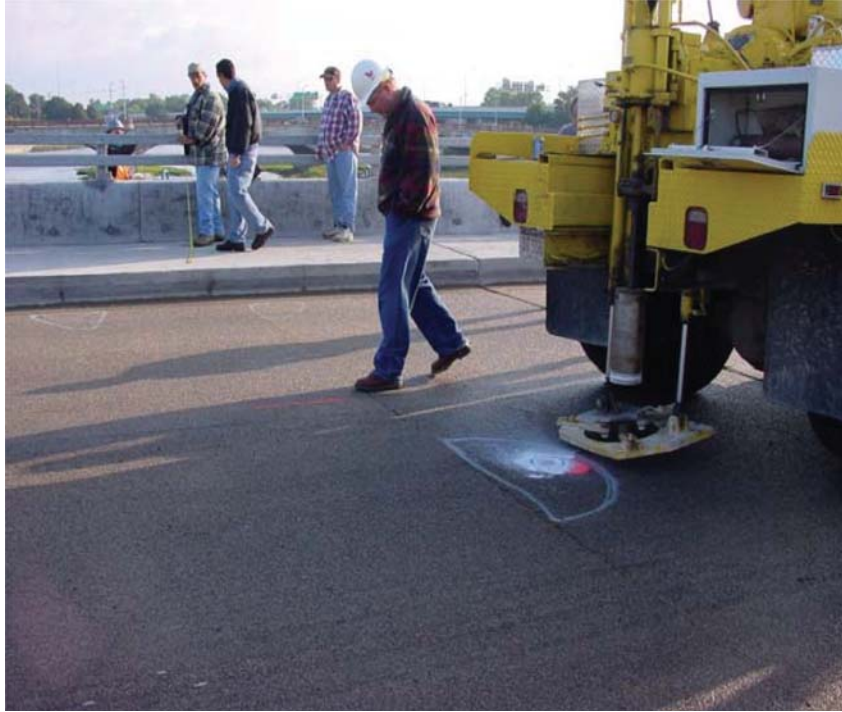
**Figure 8-1 Walk-through inspection on Salem Bridge; wear surface cracking and spalling observed.**

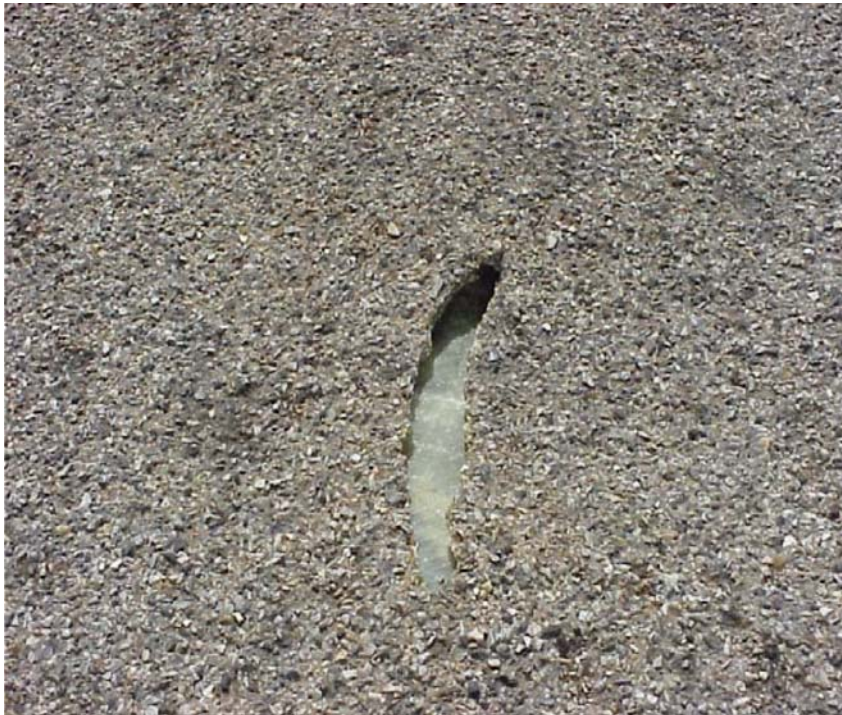
**Figure 8-2 Wear surface lift on deck.**

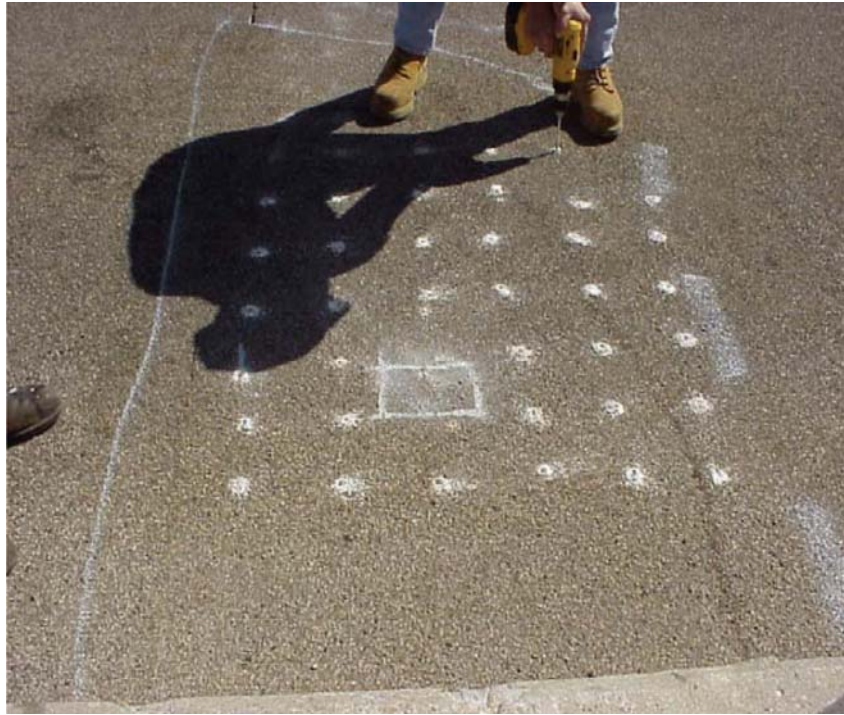
**Figure 8-3 Observed blister location on deck.**

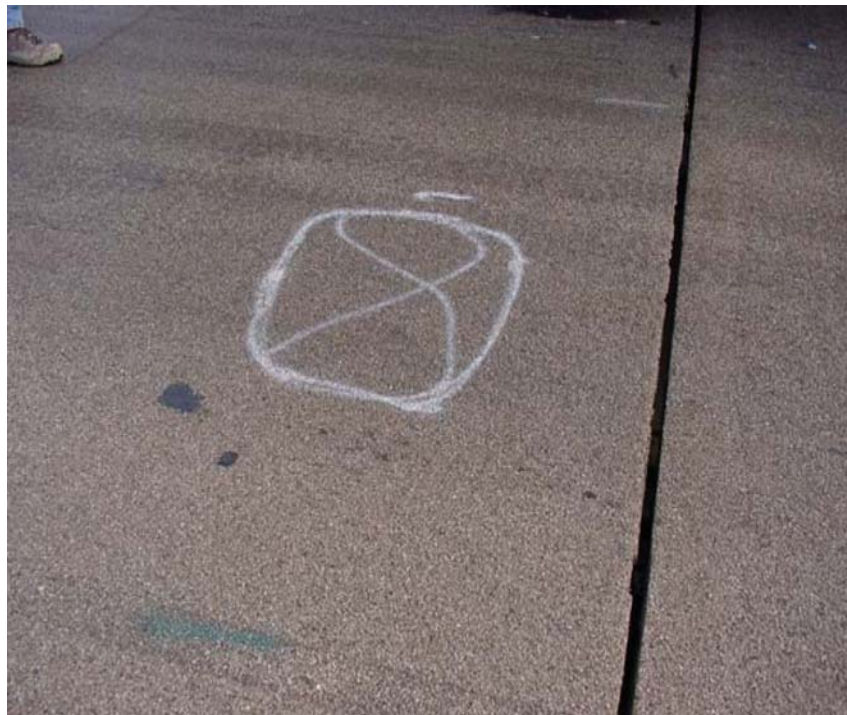
**Figure 8-6 Tap tests indicate debonding of facesheet.**

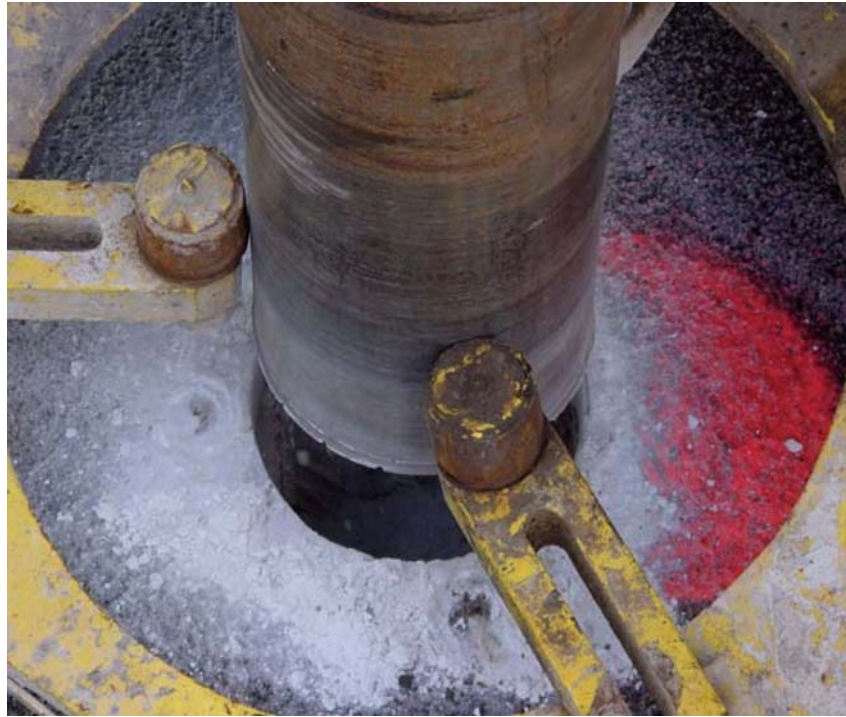
**Figure 8-7 Coring through deck.**

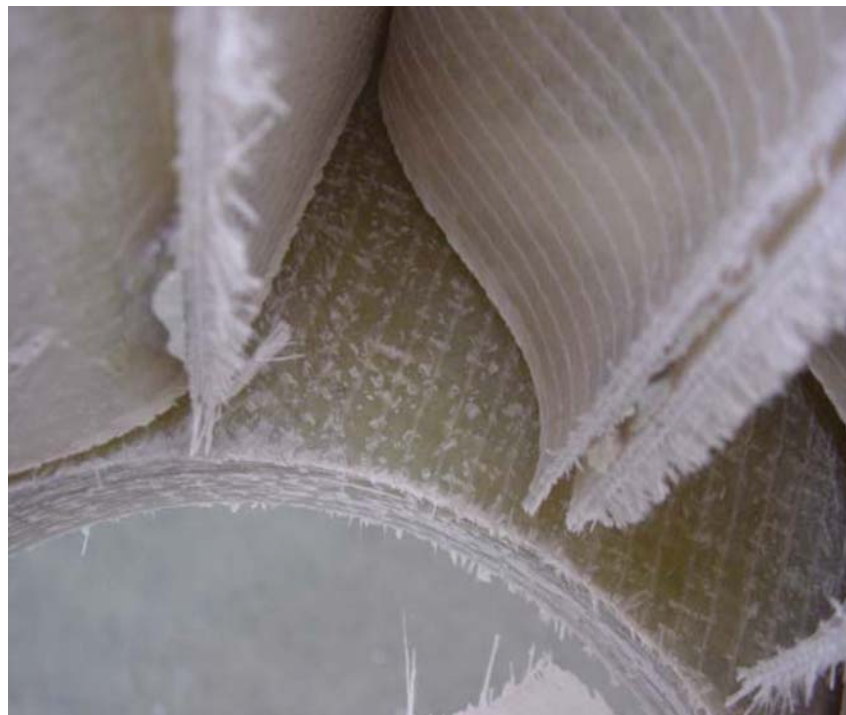
**Figure 8-8 No adhesive between facesheet and core webs.**

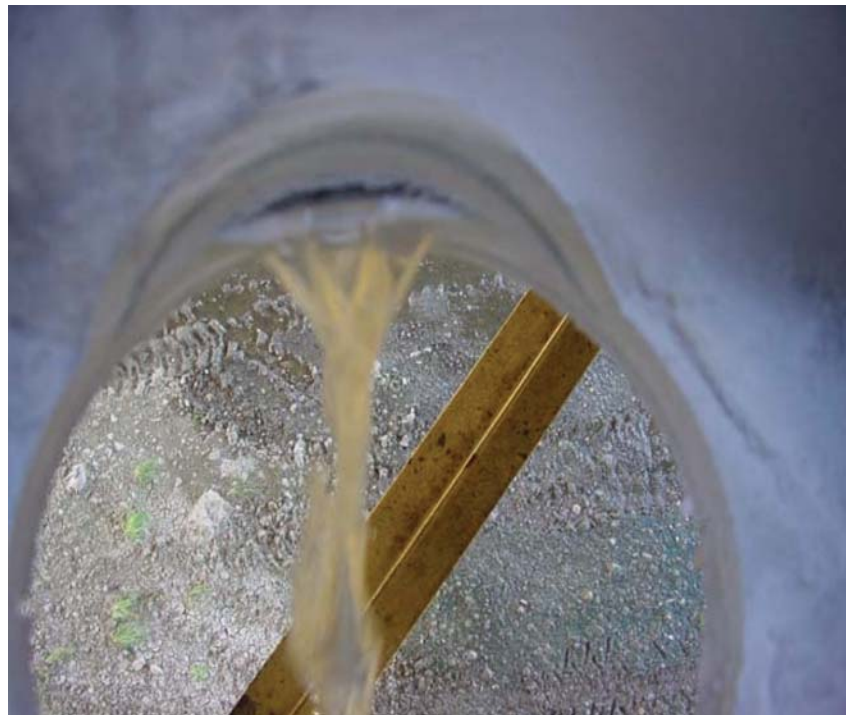
**Figure 8-10** Water accumulation in cavity of deck.

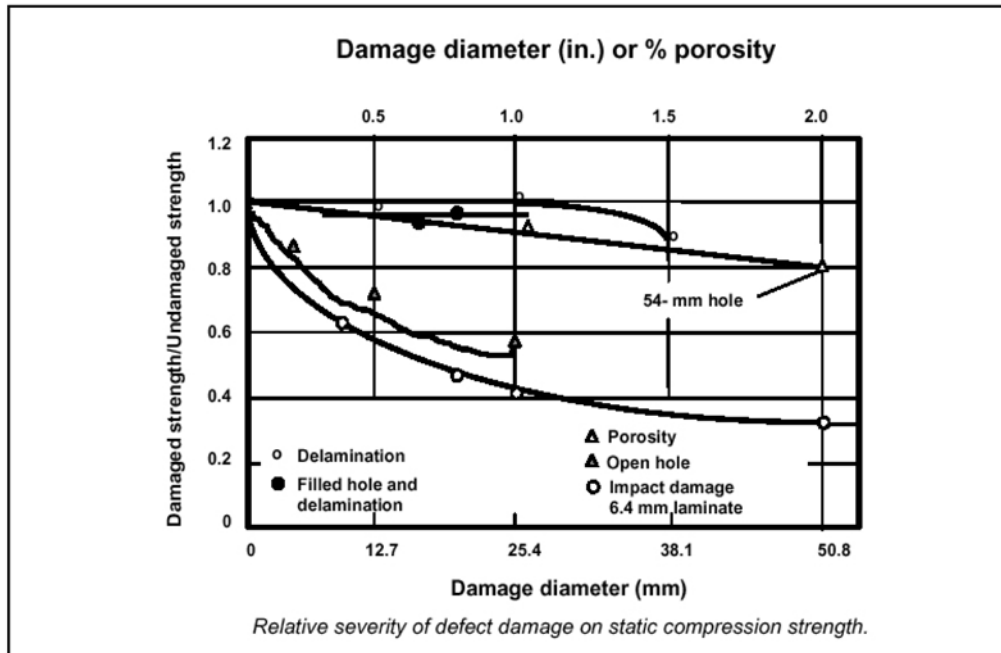
**Figure 3.6-1 Damage versus Strength Reduction (17, Figure 7.3.2[a]).**
